**APPENDICES:**

**APPENDIX C: EXISTING CONDITIONS DRAWINGS**

**CLERMONT MAIN HOUSE AREA  
ARCHITECTURAL DEVELOPMENTAL HISTORY  
1756-1971**

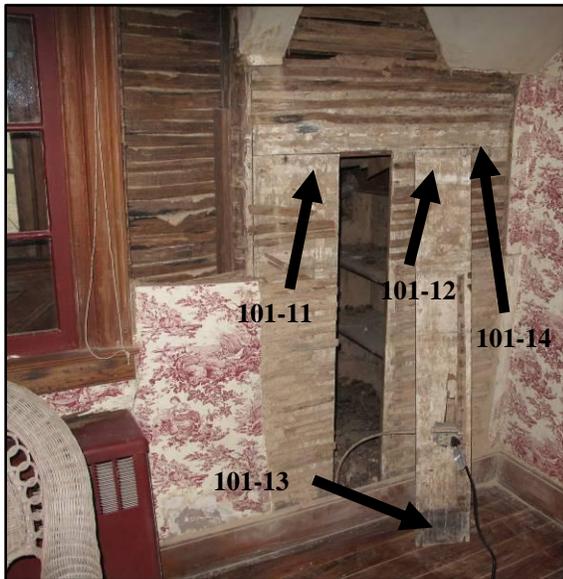
Room 101 North wall closet under stairs

During the second site visit, the northeast corner of the room under the staircase was carefully investigated to better understand the timing of the closet that was discovered by Kalbian and Pogue underneath the staircase, and to determine how this tight space might have been accessed. On the inside of the trapped closet one degraded layer of limewash was found on top of the coarse brown coat plaster substrate in sample 101-15. A delicate woman’s shoe dated ca. 1780-85 with a pinkish silk satin-covered heel was found trapped in this closet.<sup>3</sup>

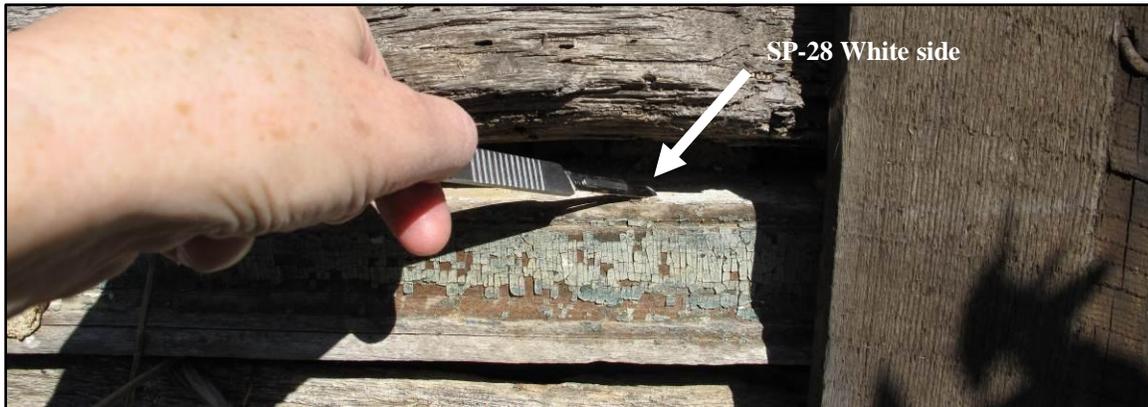
Trapped Handrail Fragment West Side of Slave Quarters

Fragments of Porch Handrail Used as Chinking on the Slave Quarters. It was exciting to search for fragments on the South Porch handrail that had been used as chinking on the 1823 Slave Quarters during the September 2012 site visit. These detached elements are quite obvious once you start looking for them. Samples were taken from the green and white-painted surfaces of one detached handrail fragment removed by Dennis Pogue, and samples were taken from green and white areas of a section of handrail still left in the south end of the exterior west wall of the Slave Quarters for comparison.

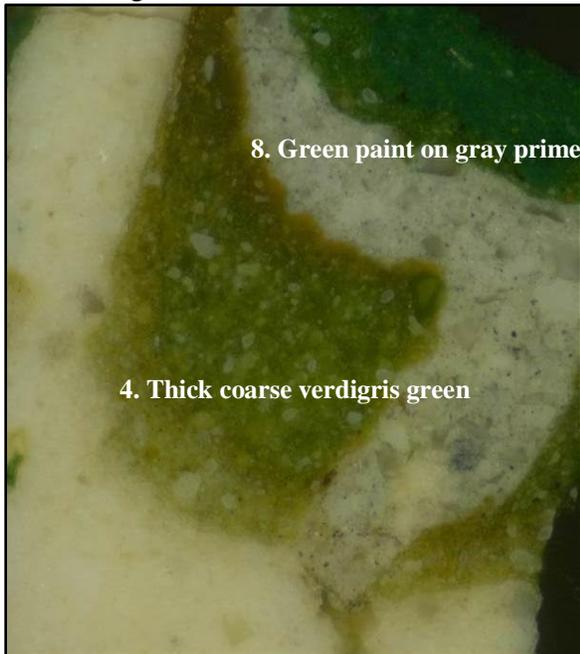
South Porch-25. Detached fragment of lower section of porch railing found by DP as a nailer in the Slave Quarters. Green paint on front edge.

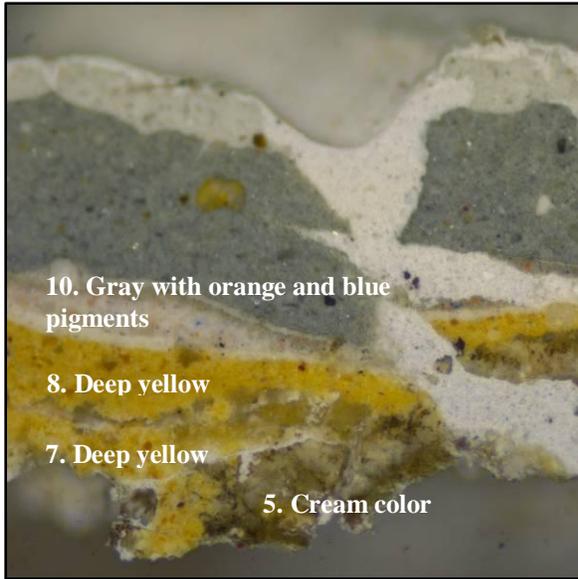
Sample EE-3 is also quite disrupted, and when its paint chronology is compared to the stratigraphy identified on protected areas of siding below the north and south elevation porches it becomes clear that the first layer remaining on this siding is generation 5. This initial dark cream-colored paint is quite degraded and discolored, but it is followed by generations 6 through 13, helping to confirm the context of the first cream-colored paint. This cream-colored paint was identified as the post-1803 paint layer on the West Frame.

East Elevation-3. Paint on siding trapped behind cornerboard left of chimney.  
Visible Light 100X

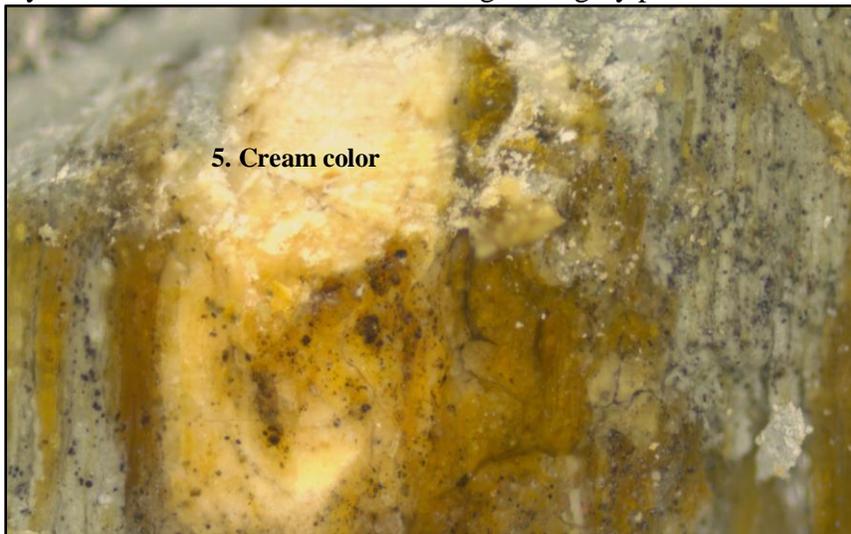
The dark gray in generation 13 is deeply weathered so it was exposed for a long time before repainting

Uncast portion of Gable-3 photographed upside-down at 40X to show the first cream-colored layer above the wood and the later degraded gray paints

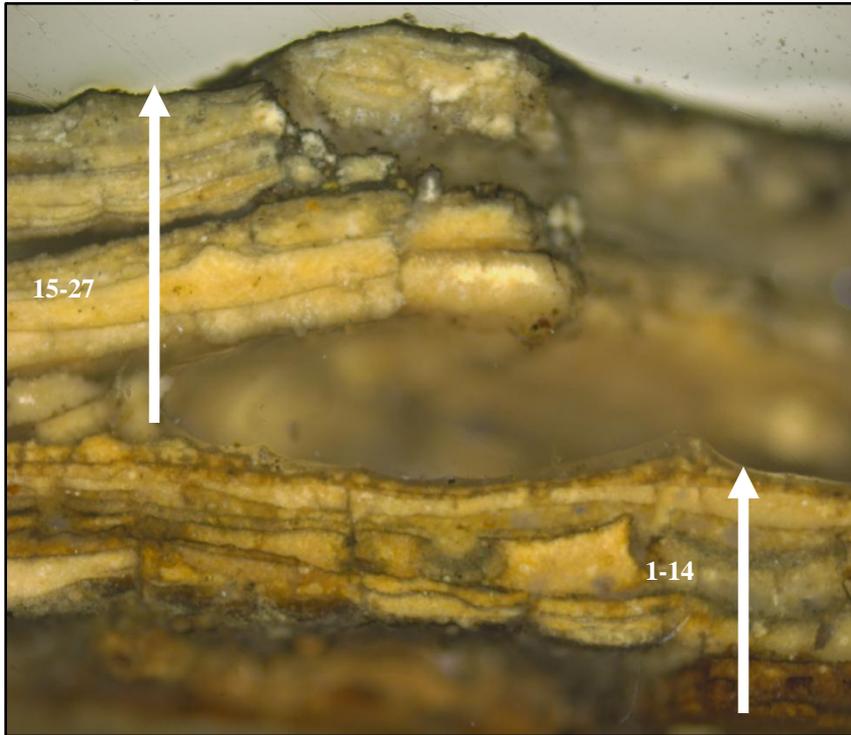
Sample K-2. West wall, NW corner, stuccoed stone wall above joist level. There is a remarkable accumulation of coatings on the stucco, beginning with similar deep orange limewashes, followed by yellow washes, and then the most recent unpigmented (white limewashes). There are at least 27 generations of coatings with dirt and soot between each layer. The first two deep orange washes are the same as those found in sample K-1, suggesting the entire room could have initially been coated with the same deep orange wash.

Sample K-2. West wall, NW corner, stuccoed stone wall above joist level.  
Visible Light 40X
