**APPENDICES:**

**APPENDIX C: EXISTING CONDITIONS DRAWINGS**

**CLERMONT MAIN HOUSE AREA  
ARCHITECTURAL DEVELOPMENTAL HISTORY  
1756-1971**

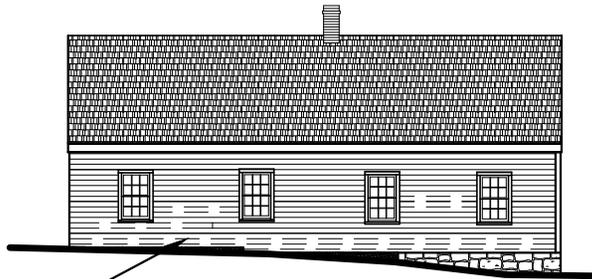
WEST ELEVATION

MISSING LAP SIDING

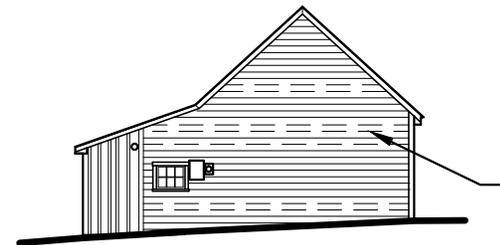
NORTH ELEVATION

MISSING LAP SIDING

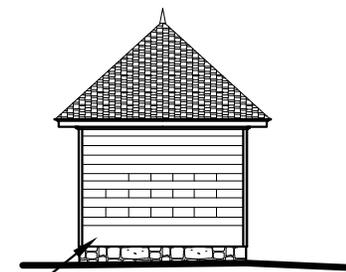
WEST

MISSING SIDING

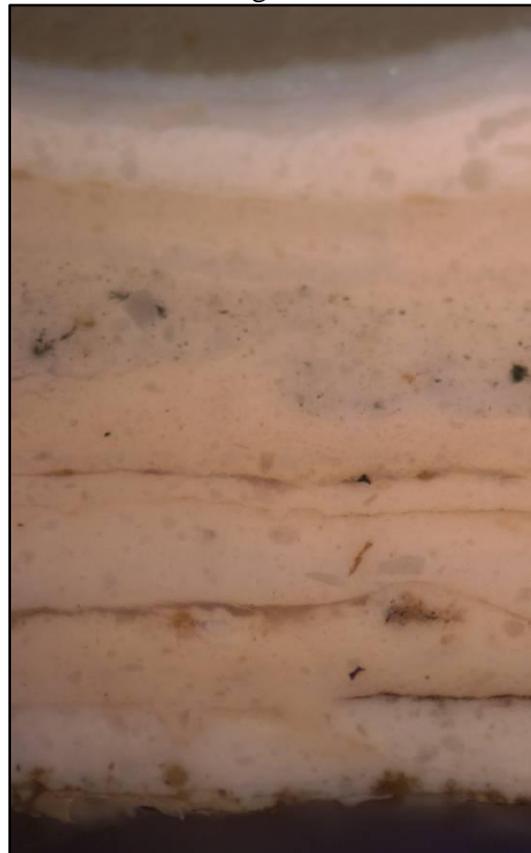
Sample 101-11. Under stairs, wide board left of narrow opening (has early blue paint).

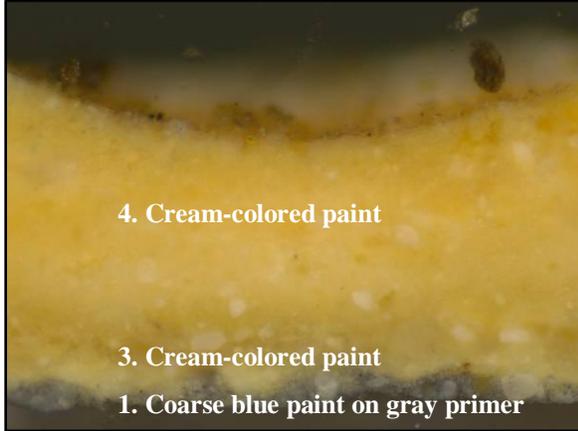
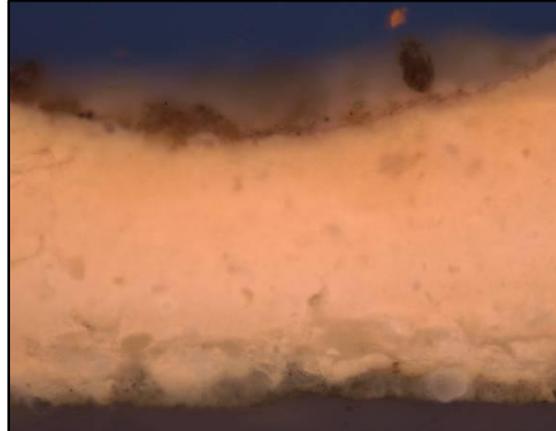
Sample 101-12. Under stairs, narrow board partially removed to create opening into original closet, accumulation of white paints towards top edge (no early blue paint).

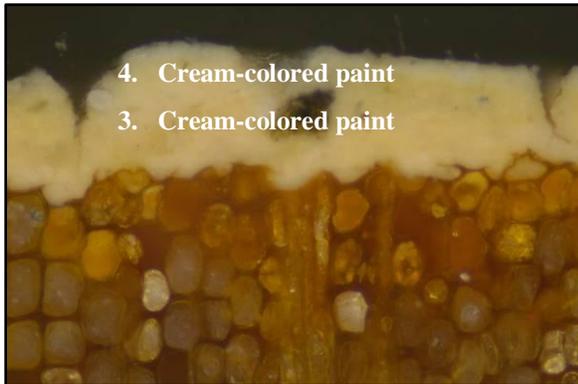
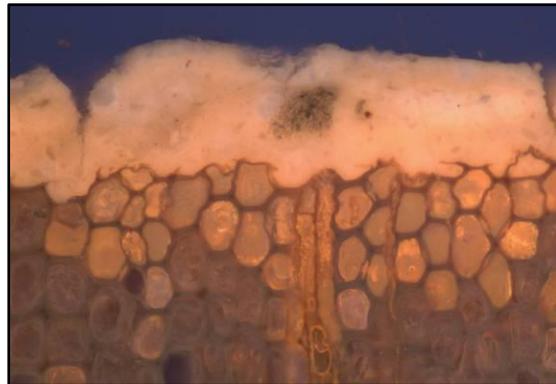
Sample 101-13. Under stairs, narrow board partially removed to create opening into original closet, on black band at bottom to create baseboard (no early blue paint).

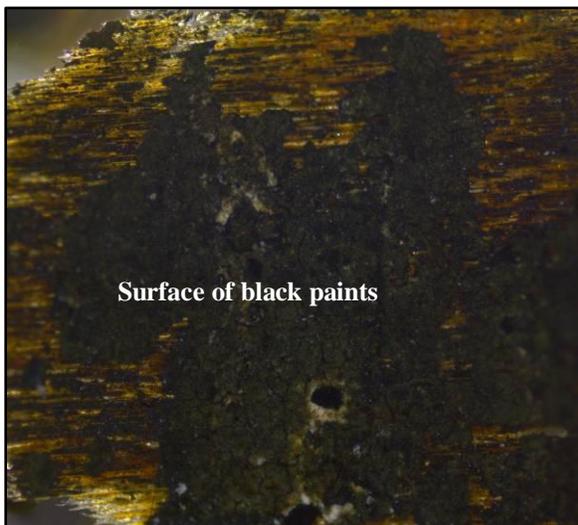
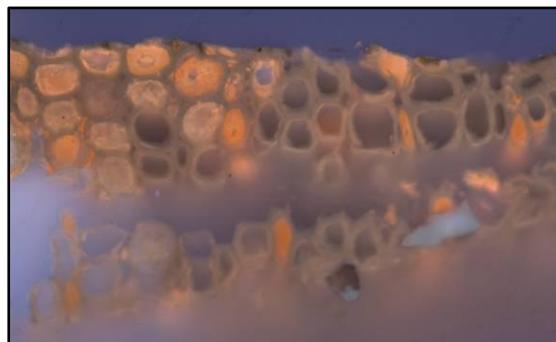
Sample 101-14. Under stairs, board at far right in northeast corner (early blue paint).

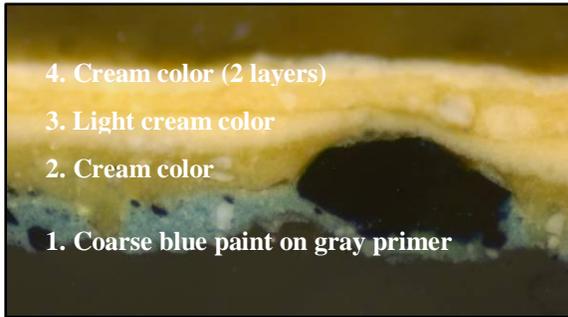
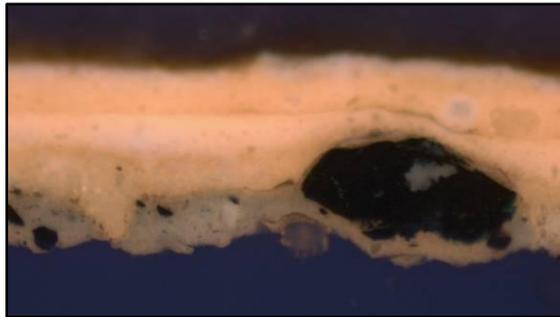
Sample 101-15. Inside closet below stairs, paint on east wall plaster.

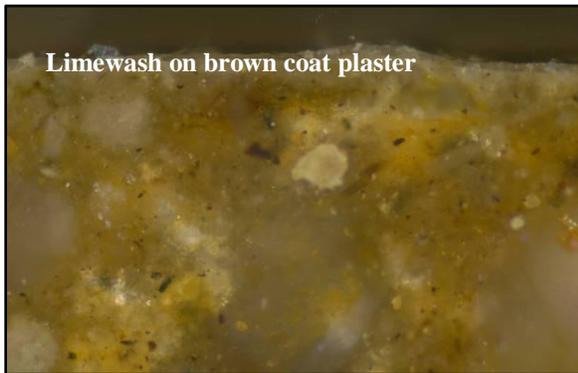
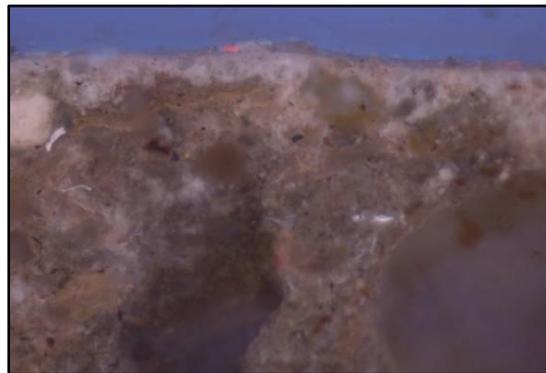
Sample 101-16. Inside closet, leading edge of top shelf (not painted).

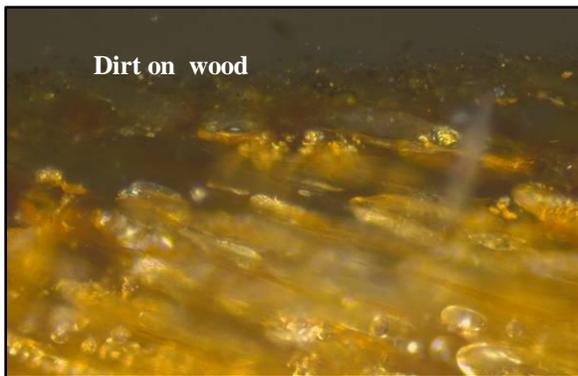
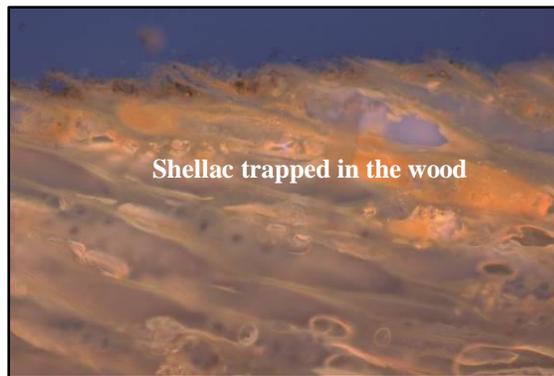
Sample 101-17. East wall, below sill for later window, trapped paint in dent.

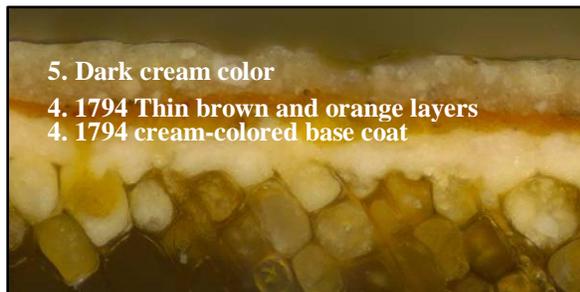
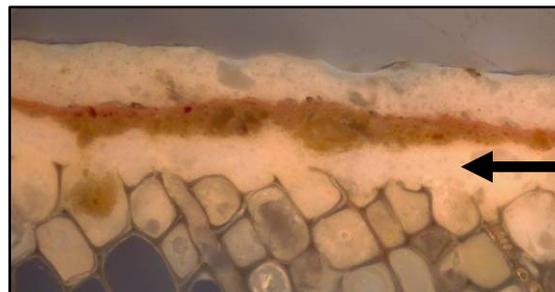
Sample 102-1. Front hall, south wall, door architrave, left side, about 4 ½-feet up.

The paints remaining in crevices of joinery and at the edges of moldings of the door and architrave on the south wall suggest that the door substantially predates its architrave. The original paint on the architrave for the south wall door (102-1) matches that on the architrave for the east wall door (102-3). The original paint on the door is a resinous orange-pigmented red-brown paint that was also found as the first paint on its exterior surface (sample SP-8).

Matches early paint in 102-3 from a 1794 architrave

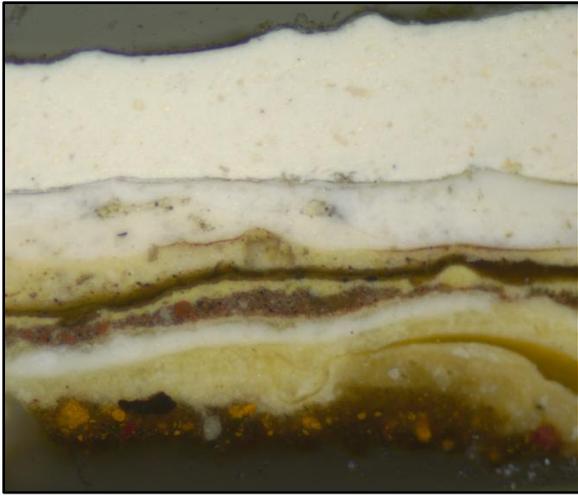
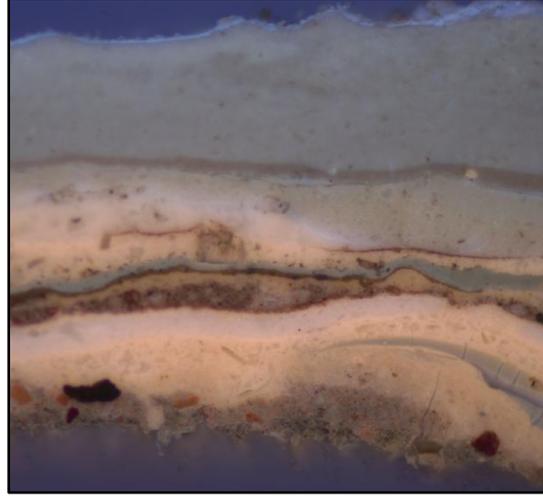
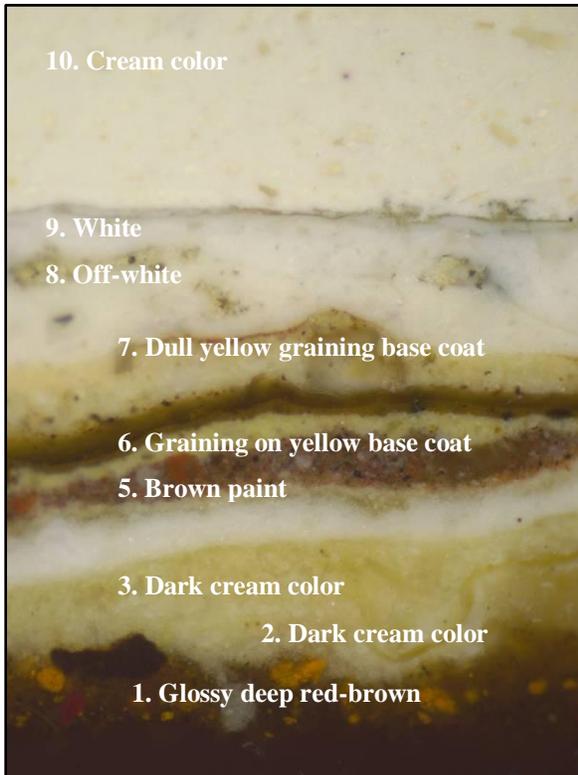
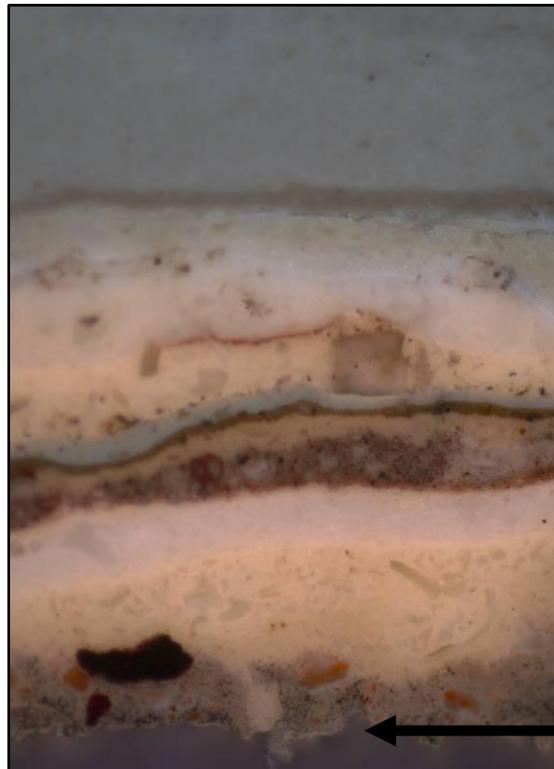
Sample 102-2. Front hall, south wall door, paint trapped in upper left corner, below upper middle rail.

*Resinous deep red-brown paint*

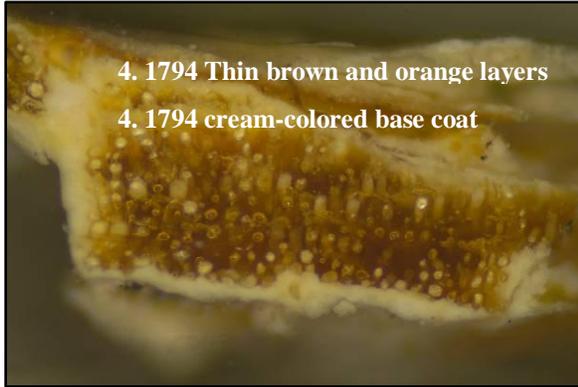
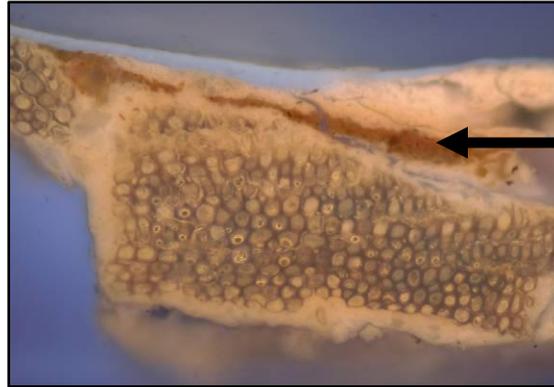
Sample 102-3. Front hall, east wall, architrave of 1794 opening, right side, about 6-feet up at paint trapped in knot.

*Matches early paint in 102-1*

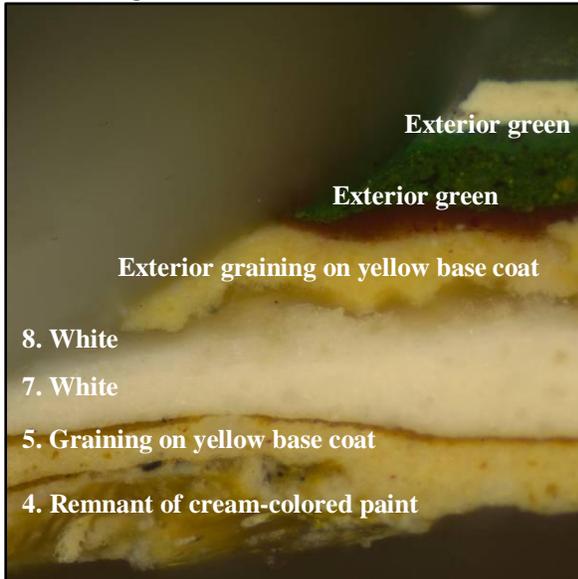
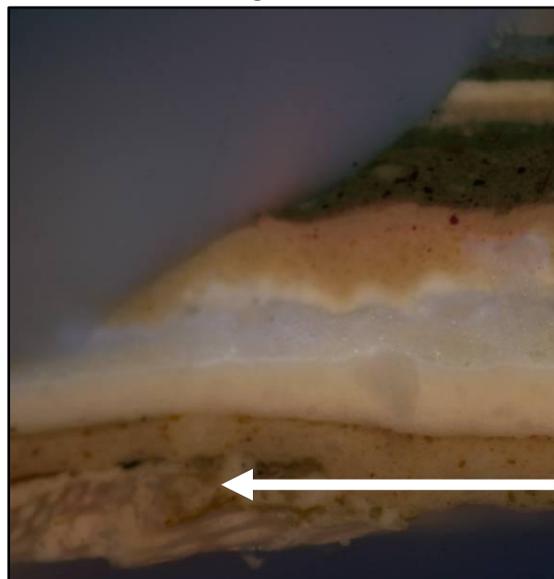
Sample 102-4. Front hall, north wall, main door, right edge.

*First layer may be generation 4*

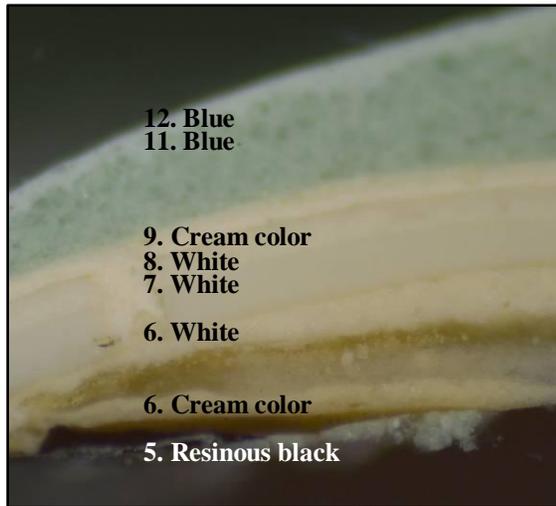
Sample 103-1. Parlor, west wall, later mantel (originally black).

The paint sequence sample 103-1 shows that the later mantel was originally painted with a

resinous, glossy black paint, like the mantel in room 101. This black paint aligns with generation 5 in the room. This black paint is followed by approximately six generations of white and cream-colored paint, up to the most recent turquoise-blue layer. The most complete paint sequence was found in sample 103-3 from the architrave for the south window. The first layer on this window architrave is a grayish-cream-colored paint on a white primer, which is followed by a similar color as the second generation.

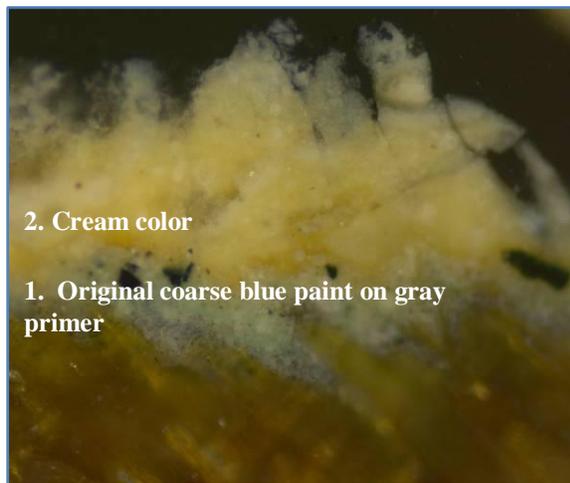
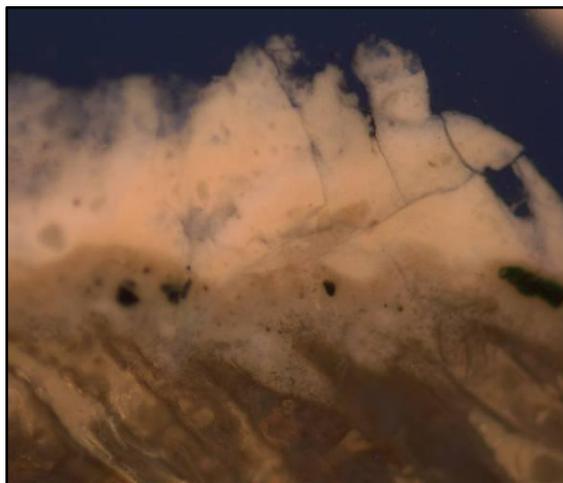
Sample 103-7. Parlor, detached section of chair board that has early blue paint.

Cross-section sample 103-7 from the detached section of chair rail is exciting because it proves that this element dates to Period I. The stratigraphy begins with the same coarsely ground blue paint on a gray primer identified as the original coatings on the earliest woodwork in the Library (room 101). The paints are quite degraded on the chair rail fragment, but the first blue finish is followed by a cream-colored paint that was not found on the architectural elements remaining *in situ* in room 103. The comparative paint sequences suggest many changes in this room took place at generation 5 when the mantel, east wall door architrave, and north wall window trim was installed, as shown the the chart below. Perhaps generation 5 is 1849 when the east partition wall was constructed.

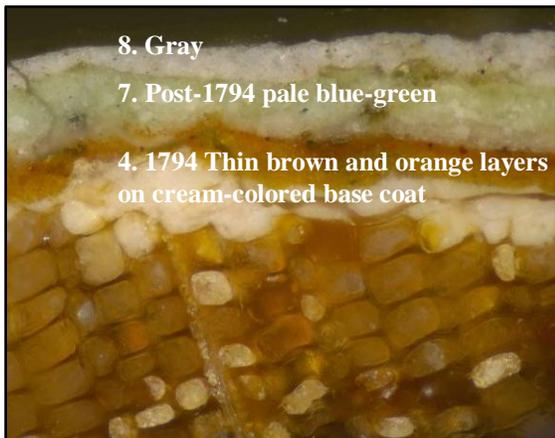
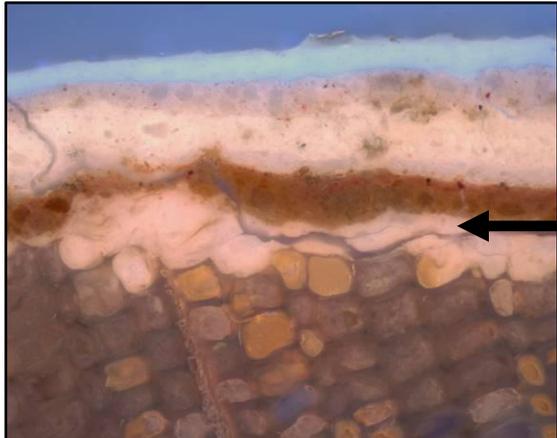
Sample 104-3. Stair, north wall, corner of chair rail, just left of window.

Matches first layer in sample 102-1 from the architrave for the south wall door in the Front Hall

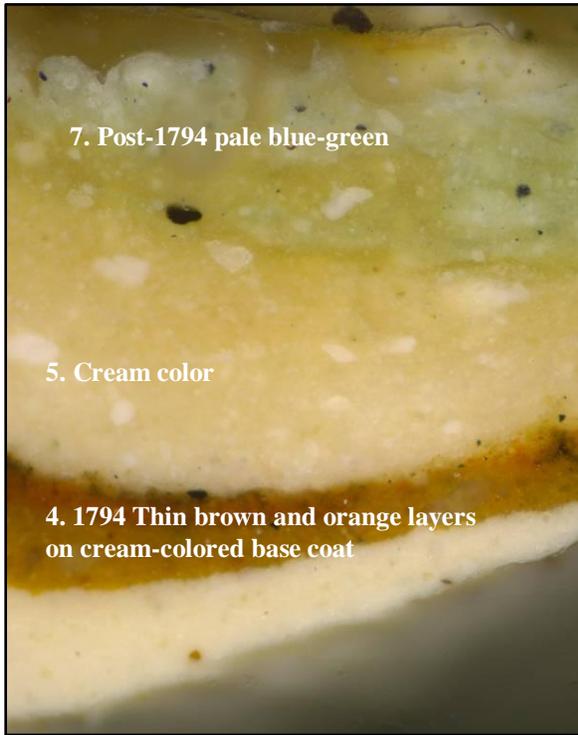
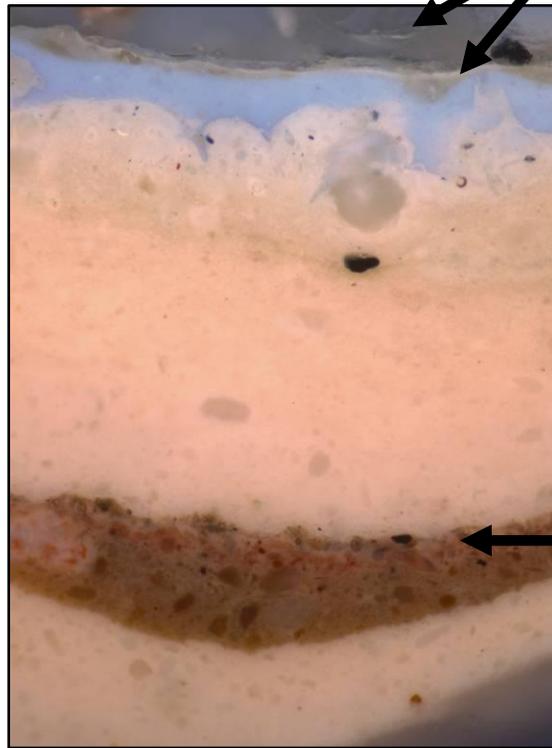
Sample 104-4. Stair, north wall, corner of panel below window.

Matches first layer in sample 102-1 from the architrave for the south wall door in the Front Hall

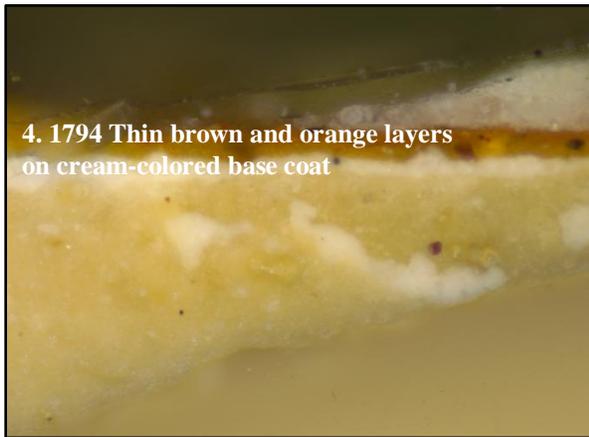
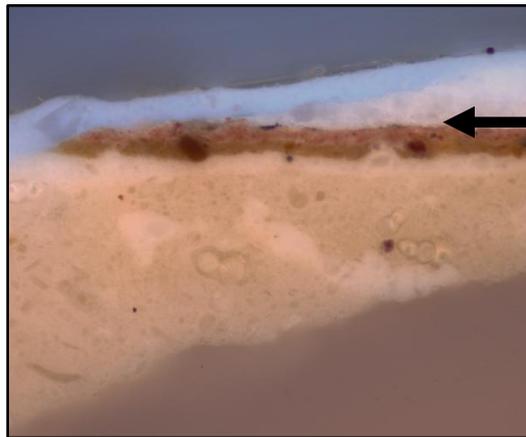
Sample 104-7. Stair, south wall, window architrave, right side, trapped in dents in backband, right side.

Matches first layer in sample 102-1 from the architrave for the south wall door in the Front Hall

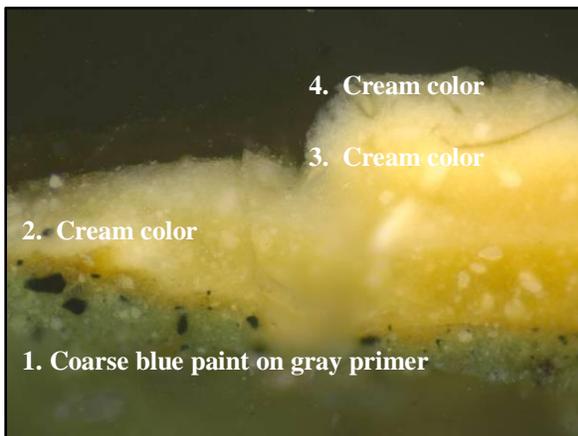
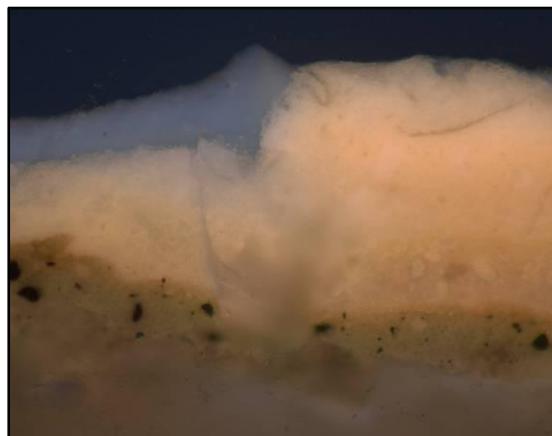
Sample 104-8. Stair, north wall, top of window architrave, early blue paint trapped in large knot right of center.

During the second site visit the depressions surrounding the large knot in the top architrave for the north wall window were examined and sampled. Fortunately, tiny remnants of the original coarse blue paint found in the Library still remain trapped around the knot. Sample 104-8 contains the original gray primer and blue finish coat, followed by two generations of cream-colored paint.

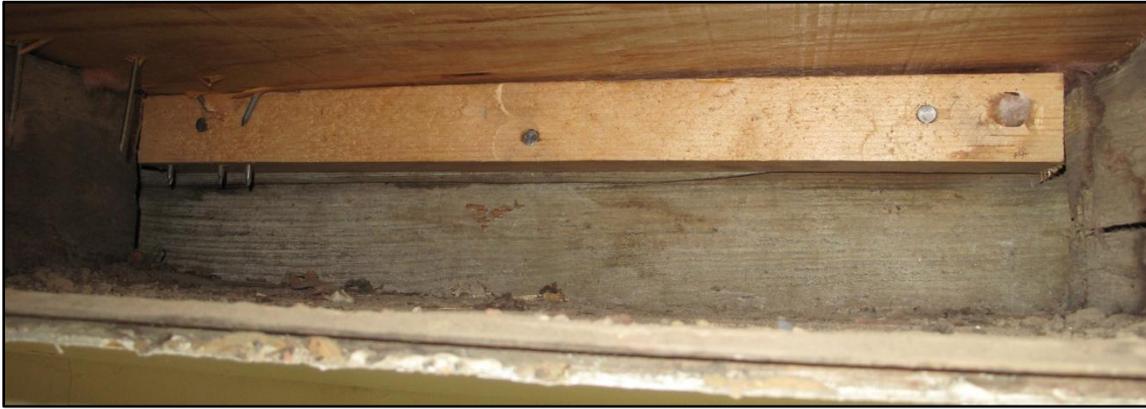
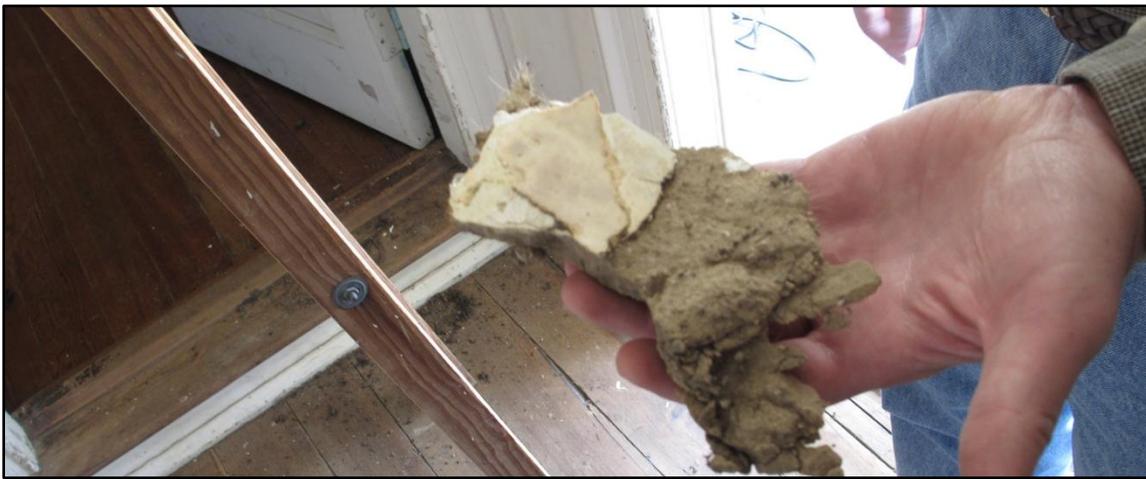
## Trapped East Wall of Closet

One sample was taken from a section of trapped plaster found on top of later plaster and nogging trapped behind the closet on the east wall of the hyphen. This sample contains only a smooth white finish plaster followed by wood pulp-based wallpaper adhered with a thick layer of starch paste adhesive. The presence of wood pulp in the paper means it must date to after about 1845 when cheaper wood pulp was introduced as an alternative to rag-based papers.

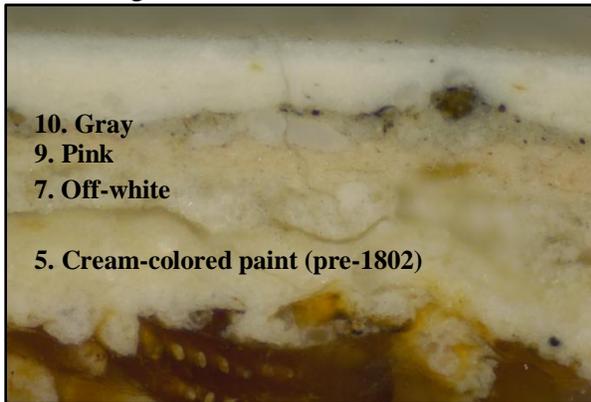
Sample 107-1. West wall above door, flush boards, should have been installed at same time as boards on west end of South Porch.

The paints on the siding and door trim (107-1 and 107-2) do not exactly line up with the coatings on the siding of the 1788 West Frame, but the surface of the wood substrate in both cross-sections is slightly dirty and discolored, helping to confirm that these elements were initially left unpainted. The first layer on top of the wood is a cream-colored paint is similar to the cream-colored paint identified as generation 5 on the South Porch siding chronology which has been comparatively dated to perhaps 1802 in sample SP-2. This comparison suggests that the cream-colored layer in 107-1 and 107-2 must date to 1802 as it is also the first layer in sample SP-7 from the West Frame and sample SP-12 from the west end of the South Porch.<sup>5</sup> It is also the only layer on the trapped siding of the east gable of the West Frame. However, Dennis Pogue noted that perhaps there were two generations of dark cream-colored paint applied within a short time and the layer on the West Gable could date to around 1794 because the West Frame was erected in 1788 and the siding on the west gable is the original siding which was covered over in 1802.<sup>6</sup> This cream-colored paint is a generic lead white and linseed oil paint, so it cannot be distinguished based solely on color and composition. So, it is possible there are two generations of the same type of cream-colored paint on some areas of the exterior – possibly to link 1794

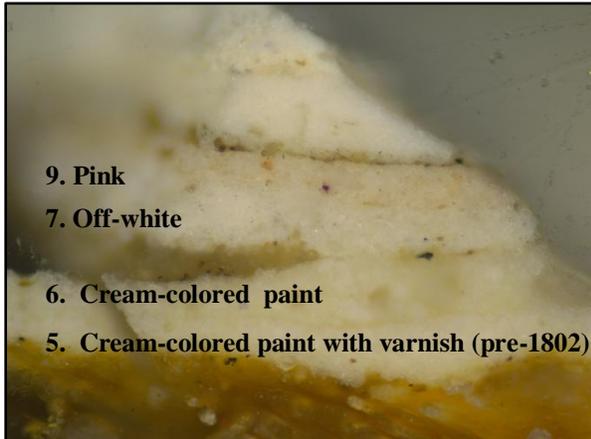
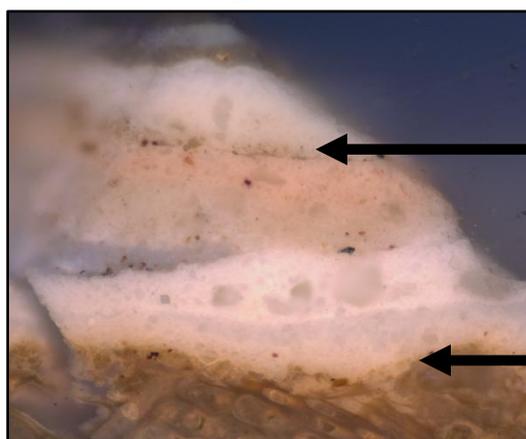
Sample 107-2. West wall door trim, upper left corner of mitered door architrave.

Grit and soot on pink paint

Grit and dirt on wood

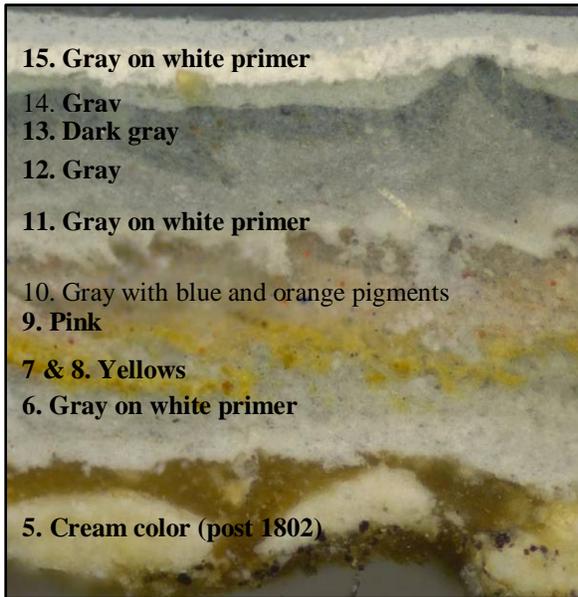
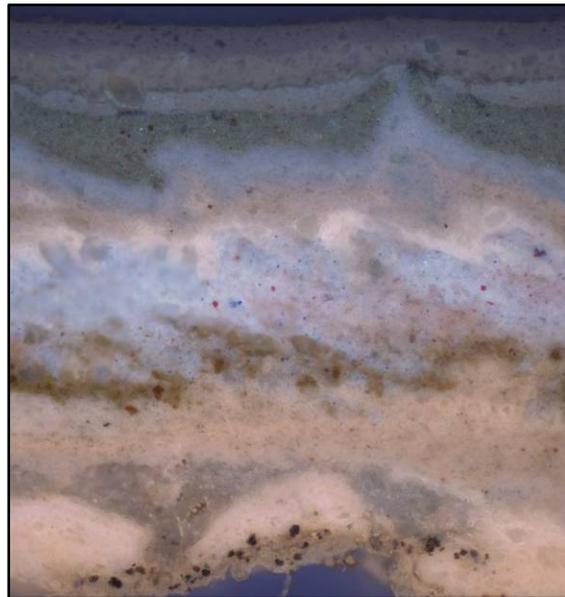
Sample SP-12. West end, siding for porch room at end.

<sup>5</sup> Dennis Pogue, email, October 21, 2012. “Dendrochronology has confirmed that the west end of the south porch – to include rafters and collars forming the hyphen roof – dates to 1802. Therefore it seems the single layer of paint found on the west gable siding MUST have been applied before that date.”

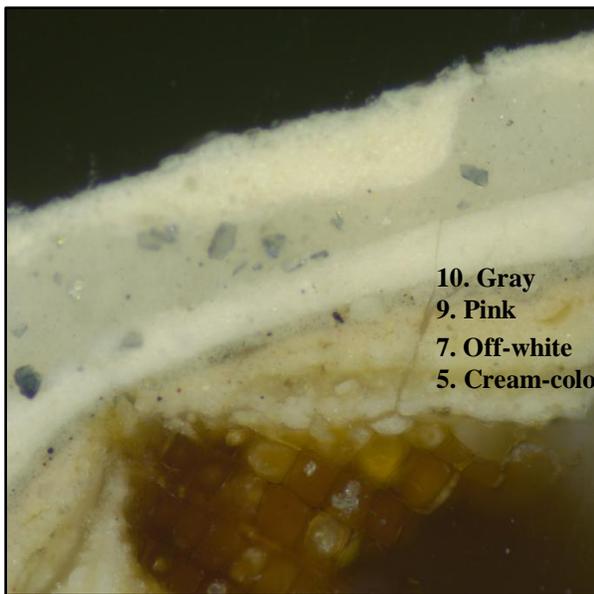
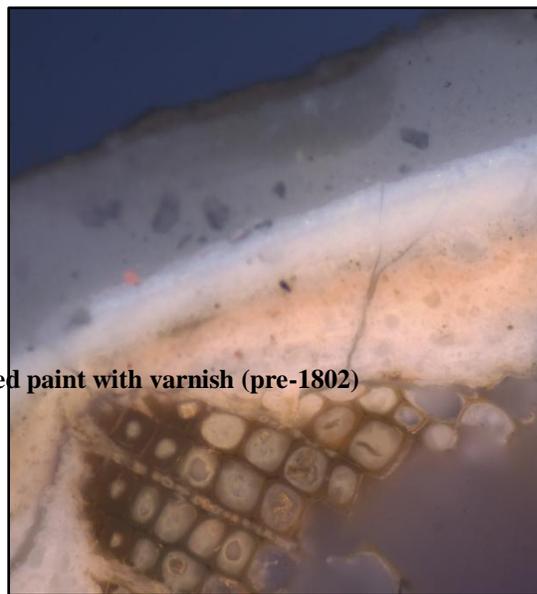
Sample 107-4. North-south ceiling board at opening.

One sample taken from the north-south ceiling board (107-4) has the same sequence as the west board wall and door architrave (107-1 and 107-2) beginning with the same cream-colored paint layer found as the first layer on the west wall siding. The sample taken from the boards that run east-west (107-5) was discovered to have a sequence of coatings identical to the north-south ceiling boards.

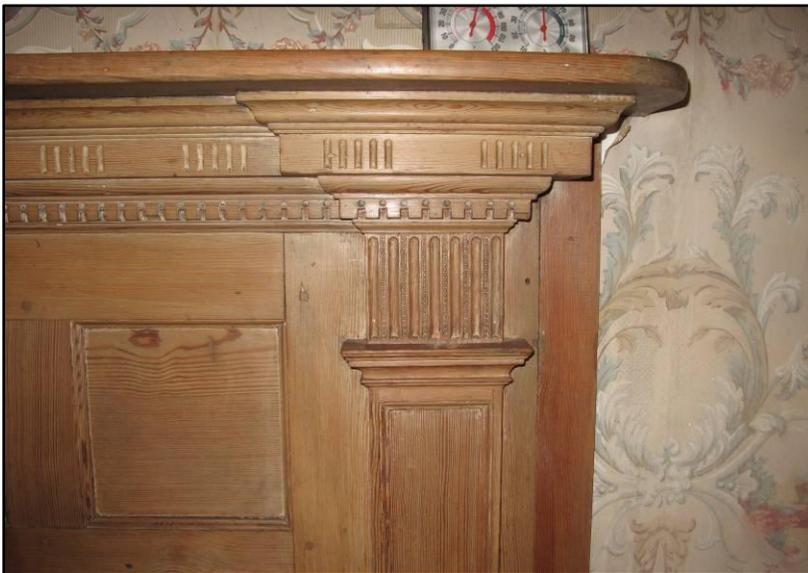
Room 110 Dining Room Mantel

The Dining Room in the West Frame dates to 1788 and the mantel could also stylistically date to the same time. Elizabeth Rust Williams suggested that this mantel might have been original to the Library and later moved to the Dining Room, based on notations in the 1947 architectural plans, so it was hoped that paint analysis could help clarify the date for the mantel. The mantel has been thoroughly stripped, but there are small areas of paint trapped in the joinery, with accumulations between the dentils and at the bases of the fluting on the pilaster capitals. Fortunately, the rest of the woodwork in this room has not been stripped. Six samples were taken from representative elements in this room during the first phase of analysis, and three additional samples were taken during the second site visit. During the last site visit one sample was taken from an opening made in the later wall plaster on wire lath where it was possible to retrieve some earlier sandy plaster. All the cross-sections contain helpful paint evidence.

The Dining Room is the only room on the first floor where a complete paint chronology remains on the woodwork. This makes it possible to relate the more limited paint evidence on the stripped mantel to the full paint stratigraphy on the door and window architraves. These comparisons are intriguing as the original paint on the architraves consists of a varnished salmon pink finish coat on an off-white primer (see samples 110-2 and 110-4). This same paint sequence was found as the earliest paint on the mantel (sample 110-1). The second generation on the architraves and on the mantel is a dull yellow paint. Neither the original salmon pink paint, nor the dull yellow paint, was found in any of the woodwork samples from rooms 101 or 103, so the comparative evidence strongly suggests that this mantel was originally installed in the Dining Room when it was constructed in 1788.

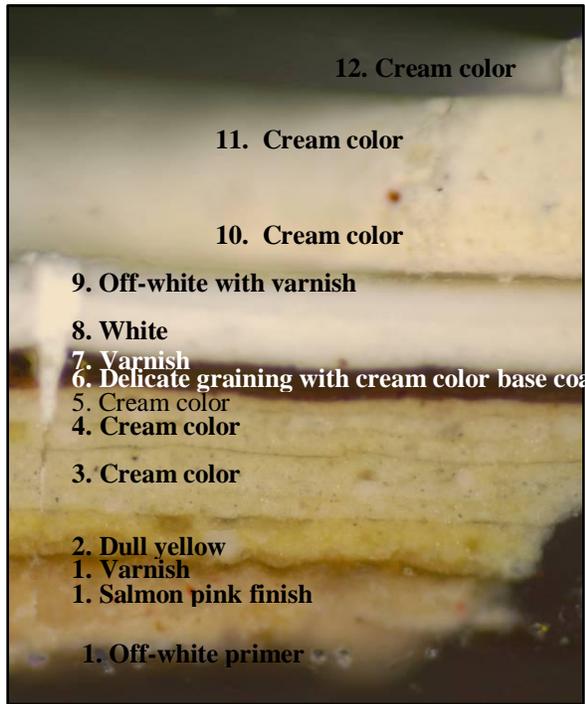
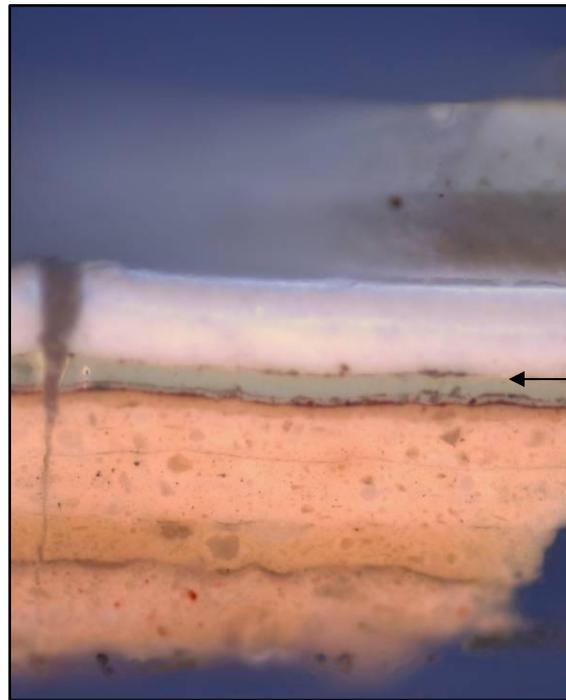
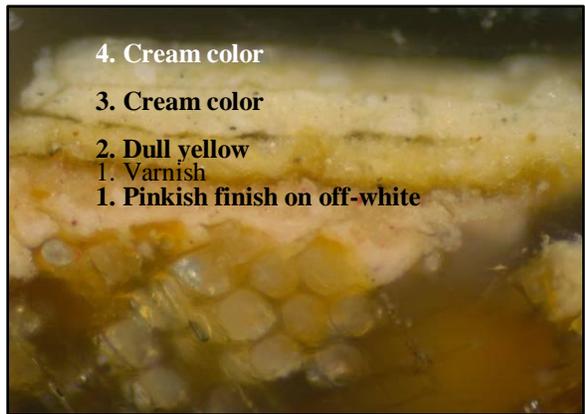
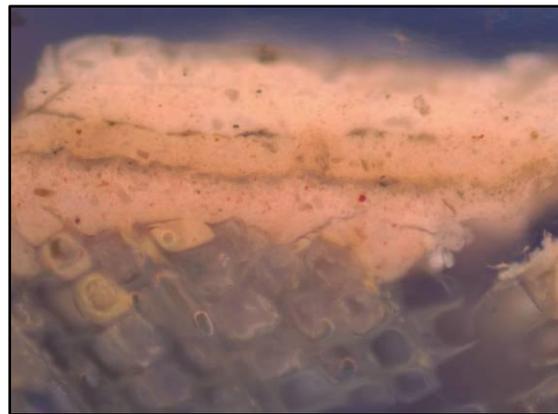
Sample 110-2. Dining Room, east wall door architrave, right side, about 5-feet up.

The evidence shows that the original 1788 palette for the room consisted of a glossy salmon pink, oil-bound paint on the architraves and mantel, off-white on the sashes, dark brown paint on the door, and tannish-brown baseboards.

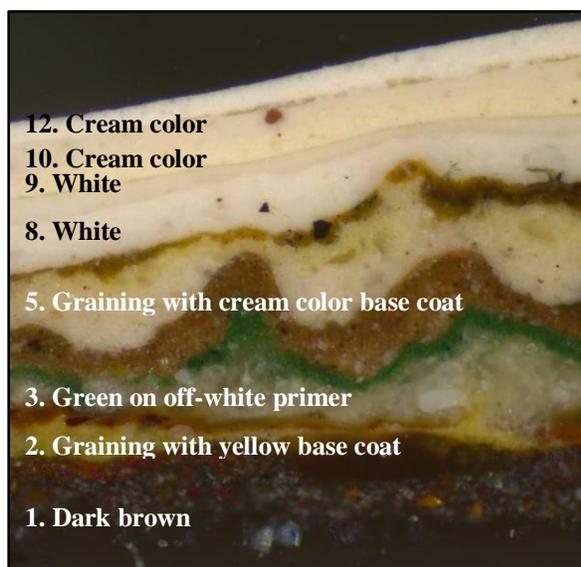
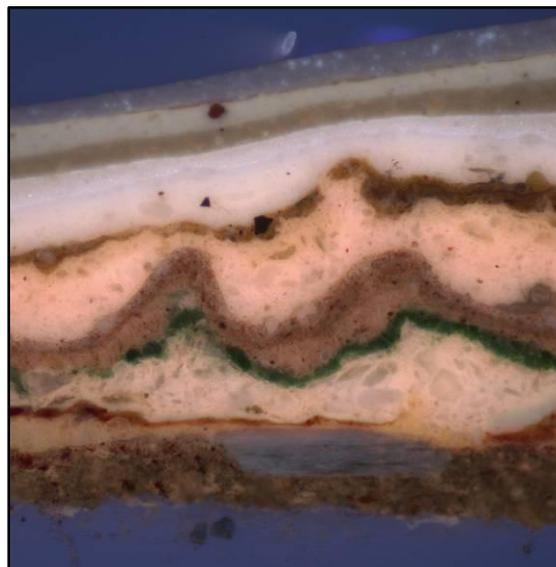
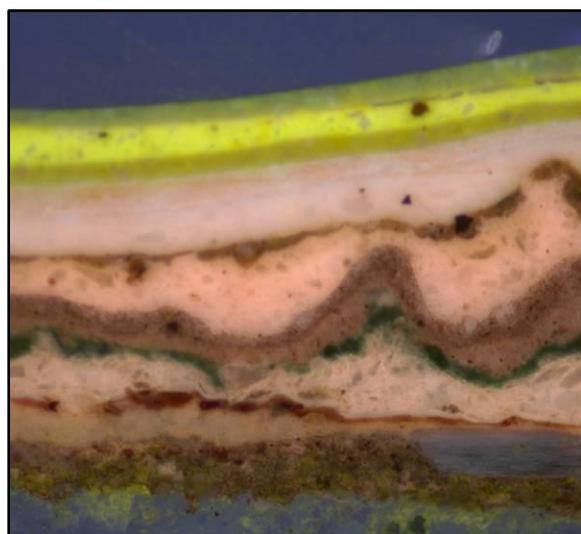
Sample 110-3. Dining Room, east wall door, upper left corner, middle left panel.

UV Light & DCF for saturated and unsaturated lipids 200X  
+ reactions for lipids (oils) to varying degrees in each layer

board door with the paints found on the 1788 paneled east wall door in room 110. It was surprising to discover that the second generation of graining with a yellow base coat is the same on both doors. Additionally, the brown paint identified as generation 4 on the door in room 110 was found as generation 3 on the board door (a comparison is shown below). Comparative cross-section analysis shows that the first layer on the board door leading to the modern bathroom is the same graining treatment with the yellow base coat. Close examination of the partition wall construction and door opening for the enclosed bathroom by Dennis Pogue suggests that the “garret doors were installed at about the same time, with the partition door most likely installed in 1788, and the bathroom door shortly thereafter (but by 1794, given that the paint layers match).”<sup>8</sup>

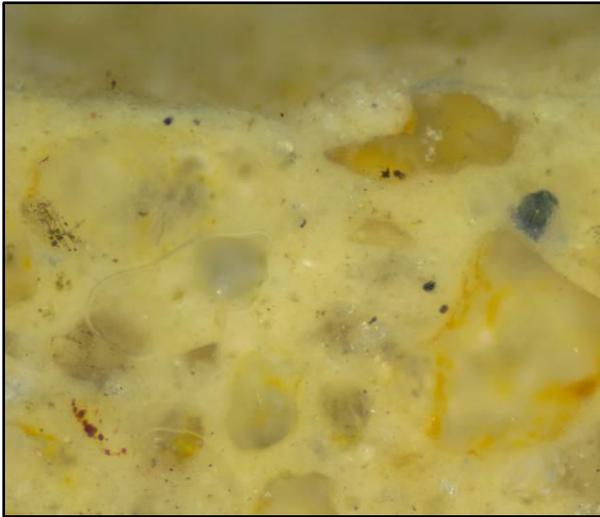
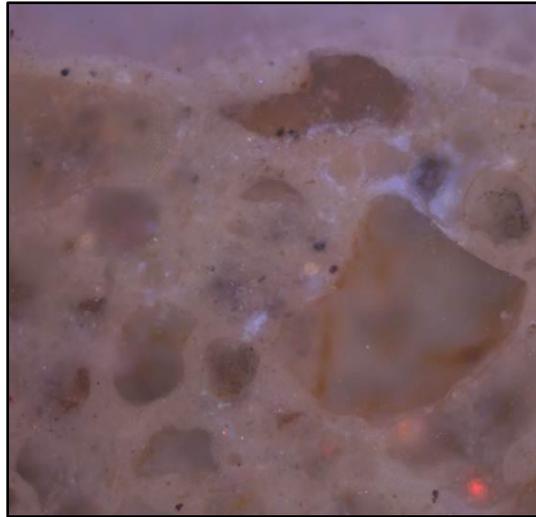
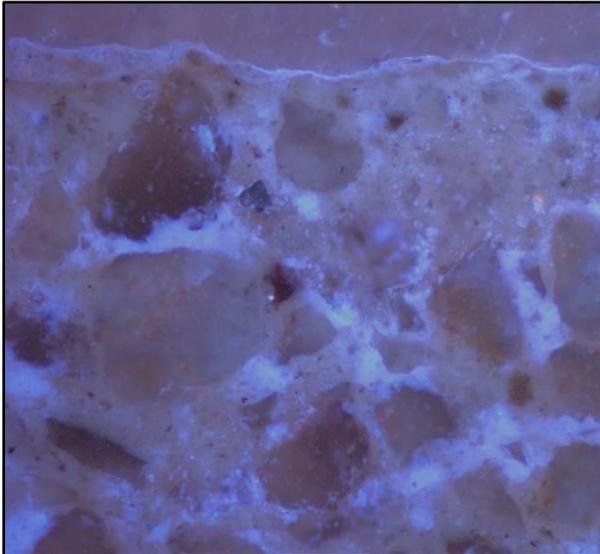
Sample 110-10. Dining room, east wall, early plaster trapped below wire lath at opening above fireplace.

UV Light & TTC for the presence of carbohydrates 100X  
+ reactions for carbohydrates in the sandy plaster

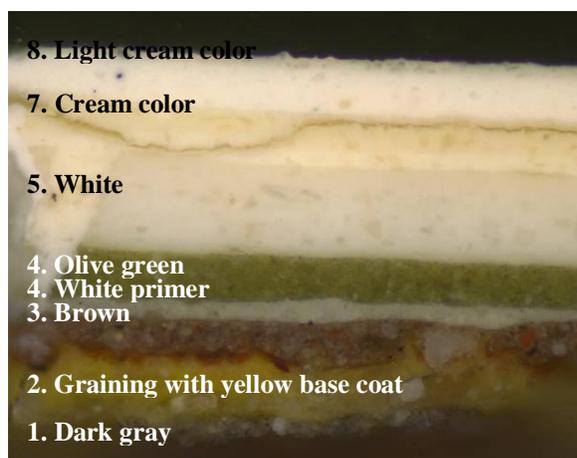
The element that retains the earliest paint chronology is sample 202-1 from the west wall board door. The original paint on this door is dark gray, which was found on both sides of the door (samples 202-1 and 204-1). This same dark gray was found as the first layer on the door architrave (202-2). It is also possible to compare the complete paint history on the west wall

Sample 202-1. Board door on west wall.  
Visible Light 200X

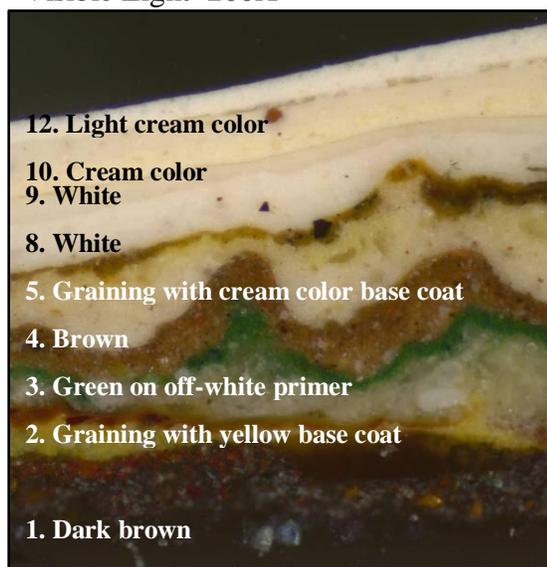
110-3. Dining Room, east wall door.  
Visible Light 200X

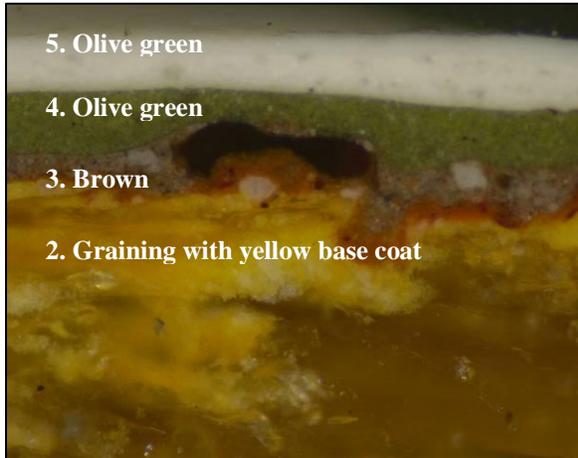
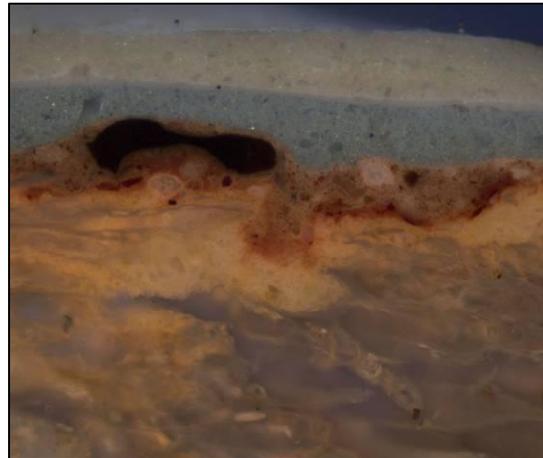
Sample 202-3. North wall, board door for bathroom.

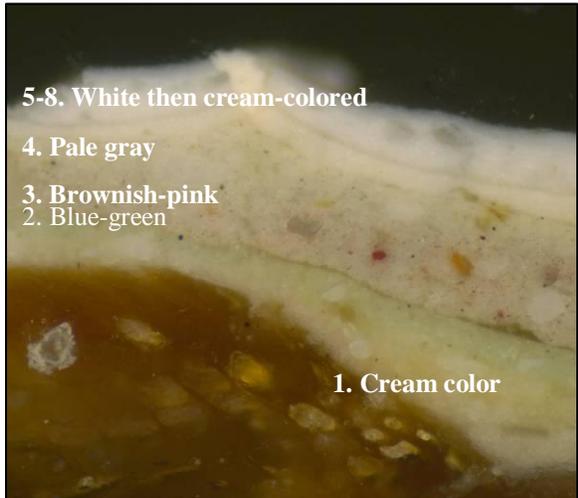
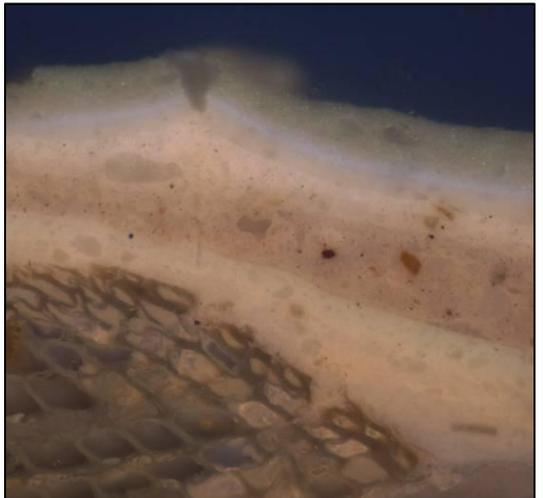
The paints on the board enclosure have a cream-colored paint that precedes the generation 2 blue-green paint, suggesting that these boards were reused from another location after the stair was enclosed in 1794 and the boards were installed along the west side of the stair case leading to the second floor. In fact, it is possible to establish a relationship between the early paints on the 1794 woodwork in the stair hall and the board wall. When sample 104-4 from the north wall paneling is compared to sample 202-4 from the bathroom enclosure it appears that the same cream-colored paint and pale blue-green paints identified as generations 1 and 2 on the board enclosure can be aligned with generations 2 and 7 on the 1794 paneling.

Sample 202-4. North wall, reused boards for bath enclosure, just left of board door.

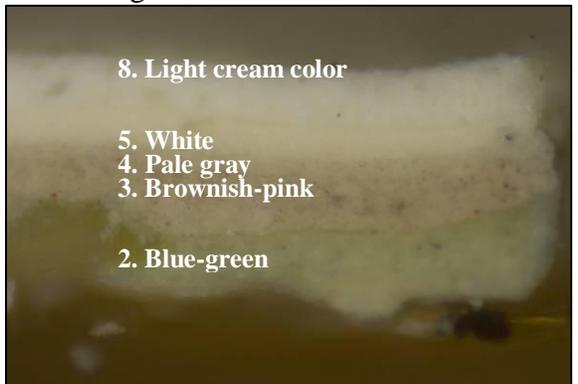
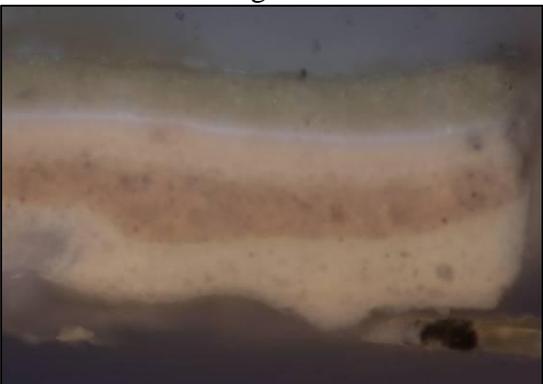
The relationship of paints between the door architrave for the board enclosure for the bathroom (202-5) and the window architrave (202-6) is somewhat puzzling as it suggests that the window architrave was installed at the same time as the architrave for the bathroom door. Sample 202-4 from the door architrave and sample 202-6 from the window architrave both start with the same light blue-green paint identified as the second generation of paint on the north wall door architrave (202-2). This suggests that the board enclosure was constructed concurrent with the second generation of paint, perhaps as a closet, and then was later converted to a bathroom.

Sample 202-5. North wall, door architrave, left side, about 5-feet up.

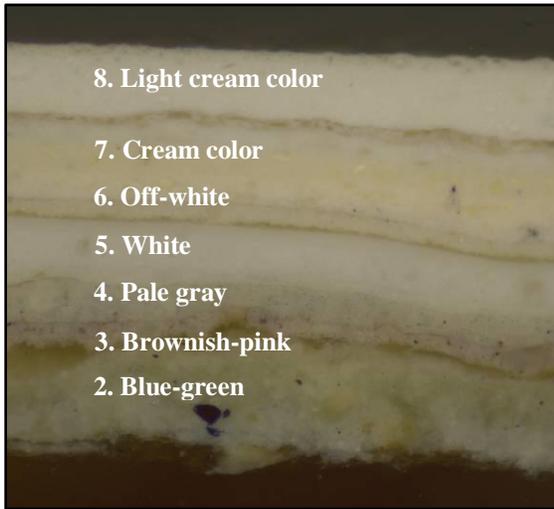
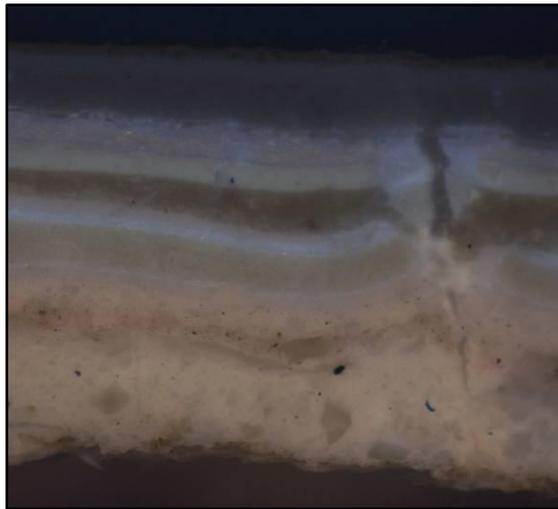
Sample 202-6. South wall, east window architrave.
