**APPENDICES:**

**APPENDIX C: EXISTING CONDITIONS DRAWINGS**

**CLERMONT MAIN HOUSE AREA  
ARCHITECTURAL DEVELOPMENTAL HISTORY  
1756-1971**

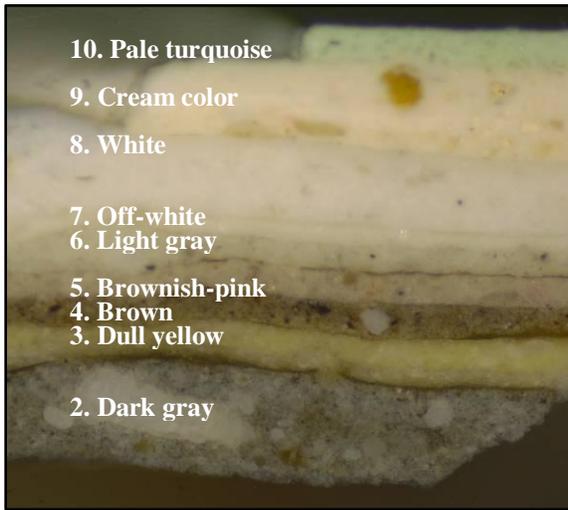
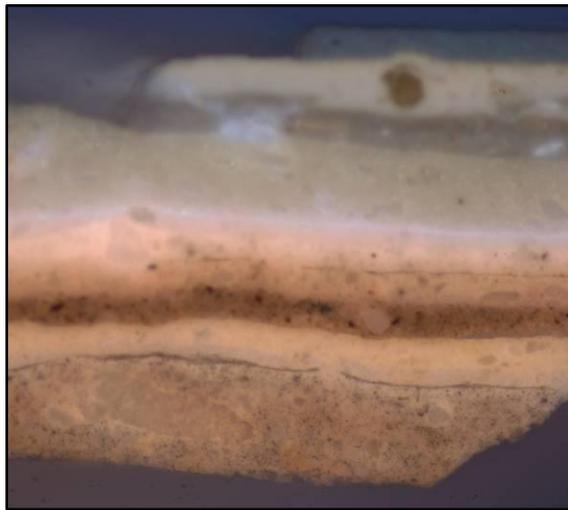
Sample 204-2. East wall, door architrave, right side, at corner of top stile and right rail (early dark gray).

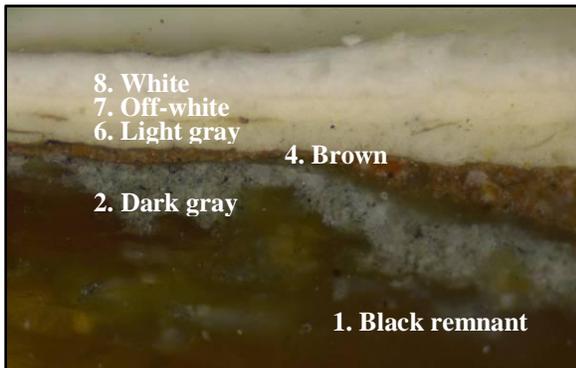
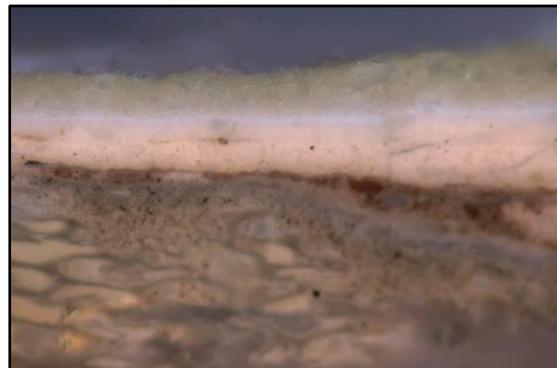
However, in this room there is a black paint on all sections of the baseboards sampled that predates the gray paint on the board door. Perhaps this means that the baseboards were installed first and painted, and then the room was not completed until the door and architrave were installed and painted gray. Or perhaps some sections of baseboard were moved from another location in the house and installed in this room when the later mantel was put in. The comparative sequences show that the paint on the mantel lines up with generation 3 and the window trim was installed in generation 4. So perhaps the current mantel was installed at the

Sample 204-3. East wall, top edge of baseboard just right of door (dark gray).

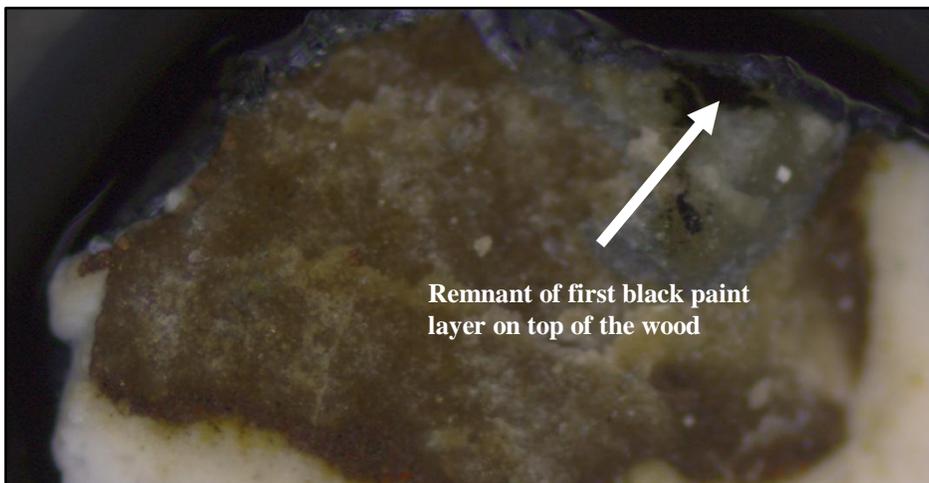
Uncast portion of 204-3 photographed at 40X to show remnants of first black paint

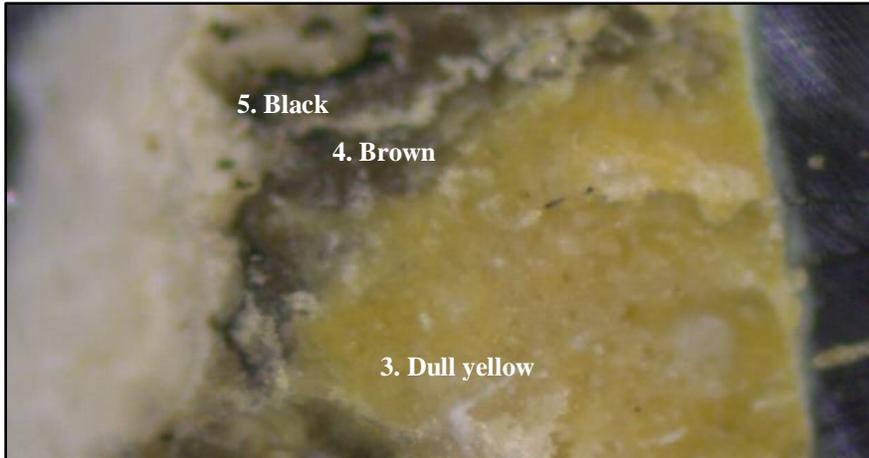
Sample 204-6. West wall mantel, frieze above right pilaster.

Uncast portion of 204-6 photographed upside-down at 40X to show first dull yellow paint

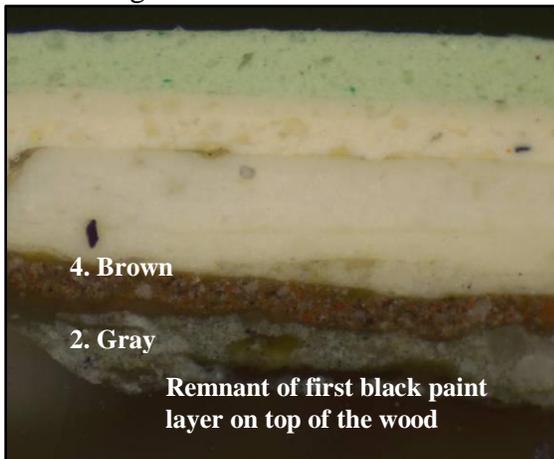
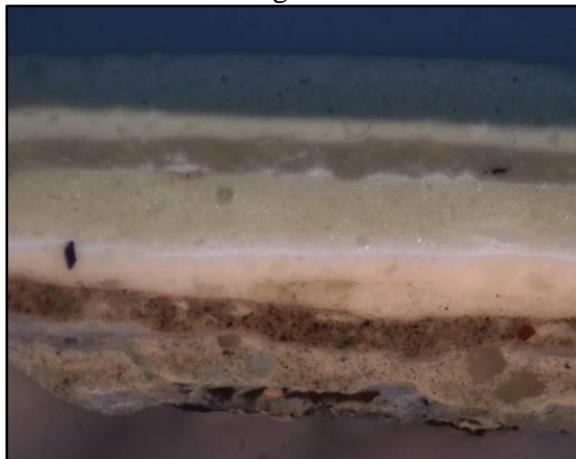
Sample 204-7. West wall, short section of baseboard that does not have a bead, just right of mantel.

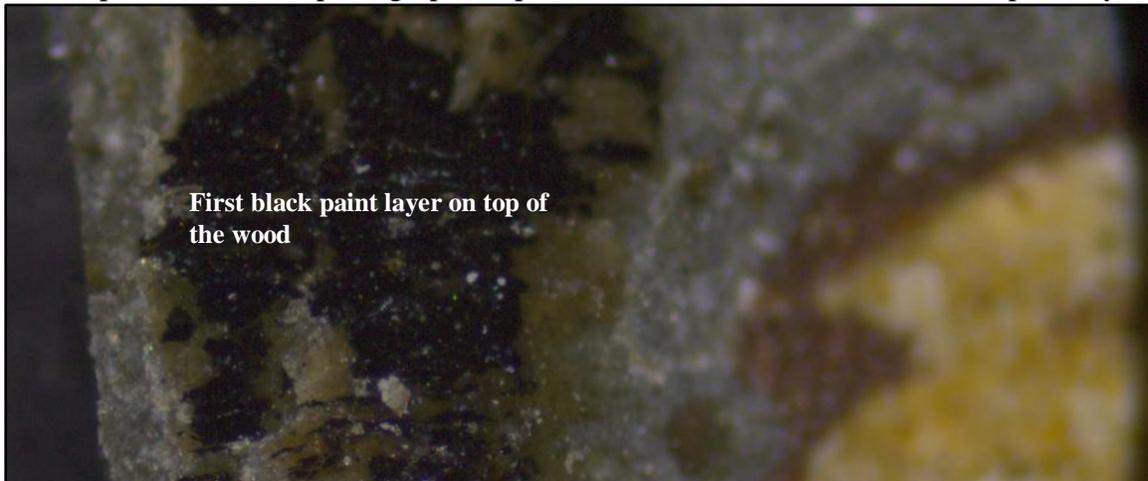
Uncast portion of 204-7 photographed upside-down at 40X to show first black paint layer

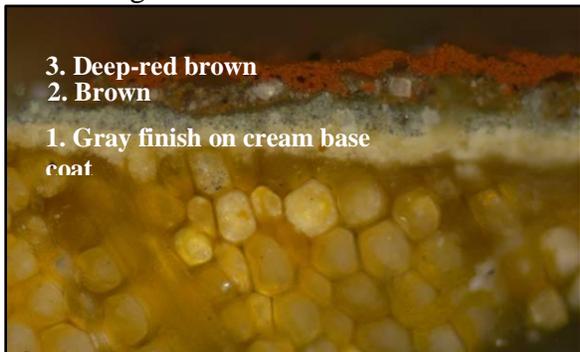
The sample from the baseboard along the south wall (Attic-1) represents an intact early sequence of three generations of paint. The original paint consists of a gray finish coat on top of a cream-colored base coat or primer. The second generation is a coarsely ground brown paint, and the third generation is a deep red brown paint that is the same coating observed as the first paint on the newel post (sample Attic-2). This same red-brown paint was found as the first paint on the stair runner (110-9) suggesting the current configuration of the stair case is distinctly later than the creation of this attic room.

Attic-1. Baseboard, south wall.

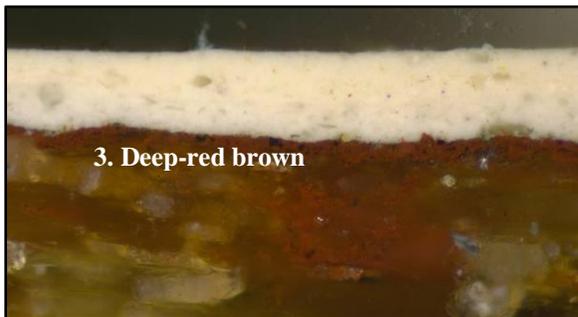
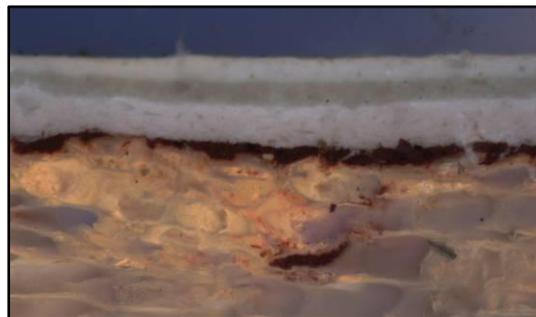
Sample 110-9. Dining Room, west wall, in stair hall, top of baseboard, left side, above third step up.

Paint history in 110-9 does not relate to room 110, but the first red-brown paint is the same as that found on the attic newel post.

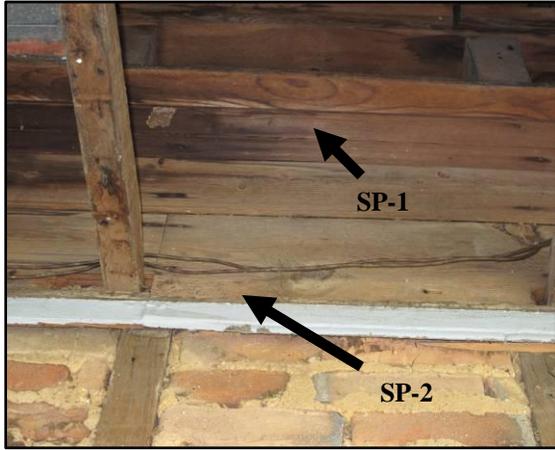
Trapped 1756 Cornice

A wide range of elements from different periods were sampled on the south elevation, so to make the comparisons easier this section has been divided by type of architectural element. Dendrochronology dating shows that the west end of the South Porch dates to 1788. There are also two periods of siding on the West Frame as the 1788 siding on the West Frame was replaced in 1802.<sup>1</sup> During the work on-site in April 2012 it was possible to gain access to several trapped elements, as sections of the porch ceiling had been opened up. Two molding fragments reused as nailers in the East and West Frame ceilings were sampled, as was the original trapped cornerboard for the East Frame. It was also possible to see more clearly in this same area that the original cornice for the East Frame had never been painted.

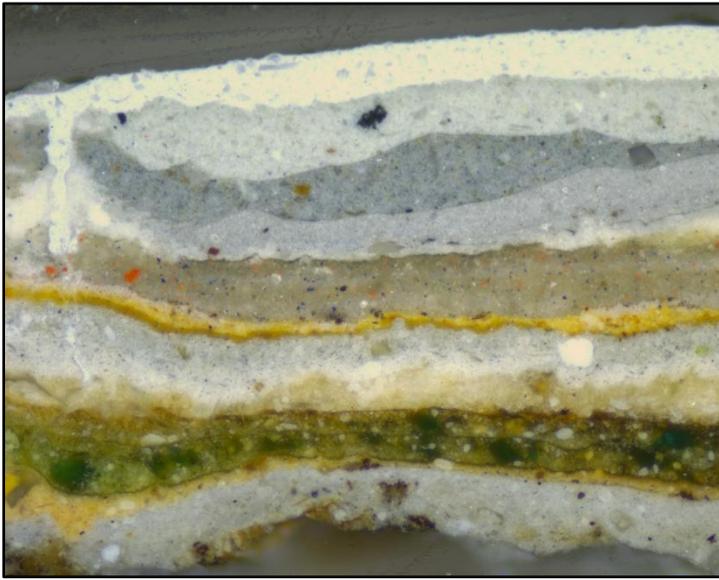
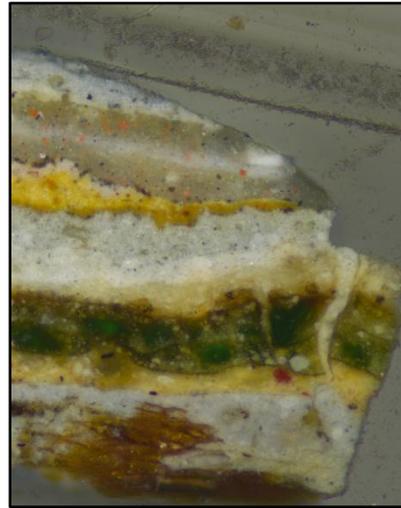
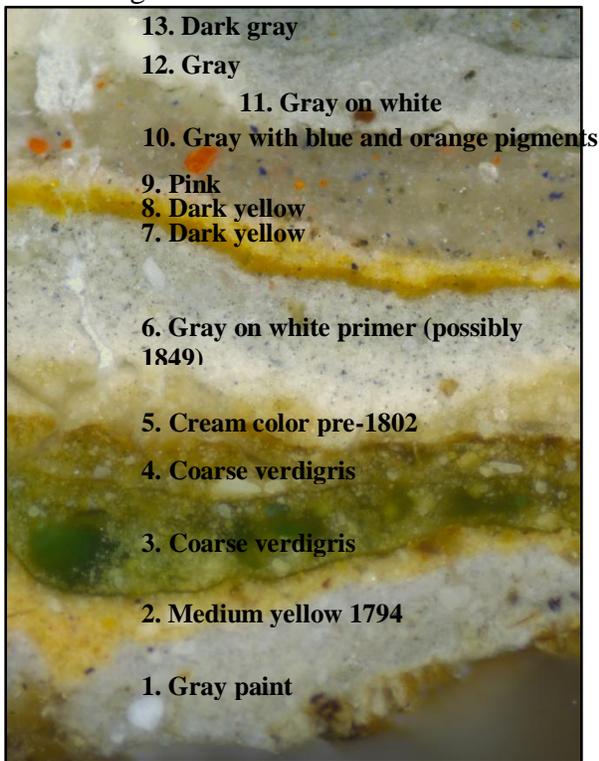
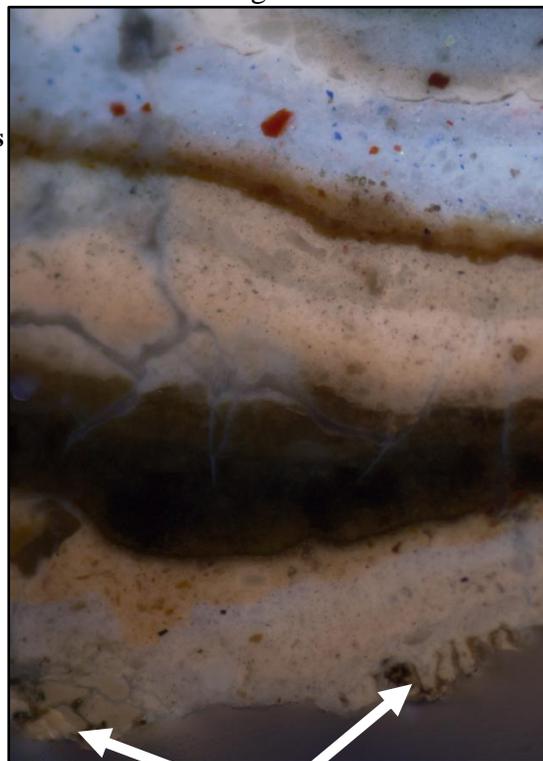
Sample SP-2. East frame, original siding just below ceiling level.

**Siding.** The narrow original siding below the cornice was also sampled to see how the 1756 siding was originally coated, and to establish the early paint chronology for comparison with the wider 1794 siding. The wood substrate in cross-section sample SP-2 from the narrow siding below the trapped cornice is fragmented and degraded, suggesting the siding was originally left unpainted. The chronology begins with a gray paint on top of the darkened wood substrate. The second generation is medium yellow, and the third and fourth generations are similar coarsely ground, unevenly mixed, verdigris-based, green paints. This is a remarkable discovery. This type of brilliant green paint was often used on exterior louvered shutters, and was considered a very stylish paint for eighteenth-century interiors.<sup>5</sup> But verdigris is an unstable copper-based pigment and paints containing it degrade quite quickly to dark brown or black, especially when directly exposed to sun. The discovery of this relatively expensive, brilliant green paint on exterior siding is astonishing and no other example of this type of exterior use comes to mind.

Fragmented, dirty wood substrate

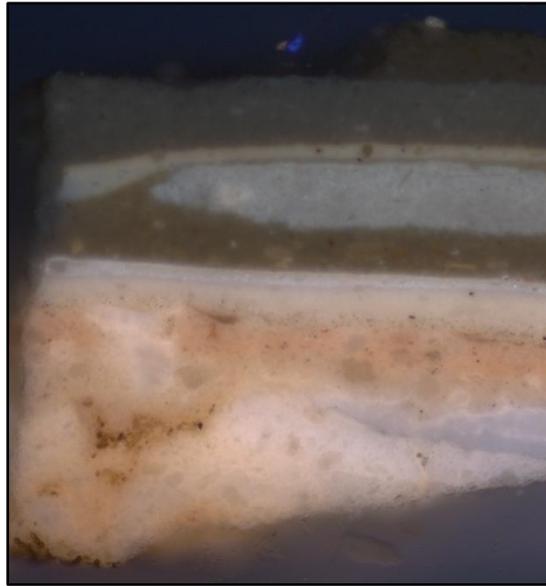
Sample 107-1. West wall above door, flush boards, should have been installed at same time as boards on west end of South Porch.

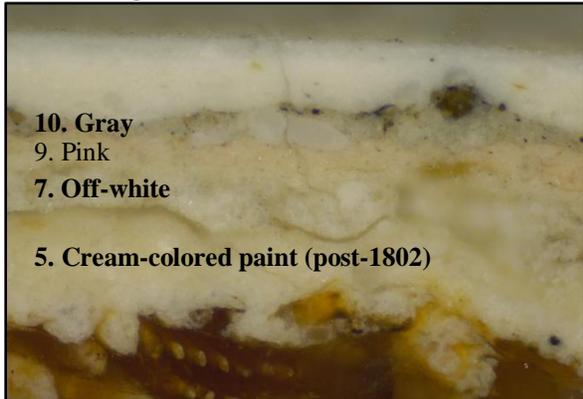
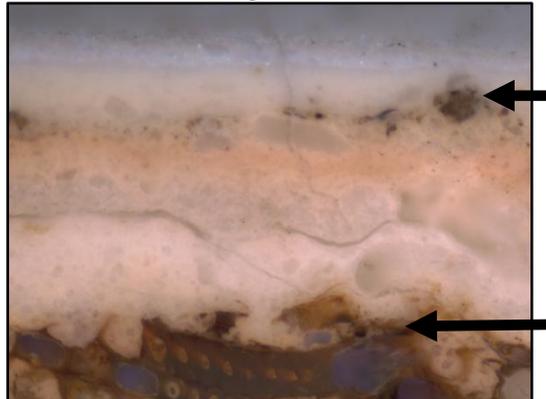
← Grit and soot on gray paint

← Grit and dirt on wood

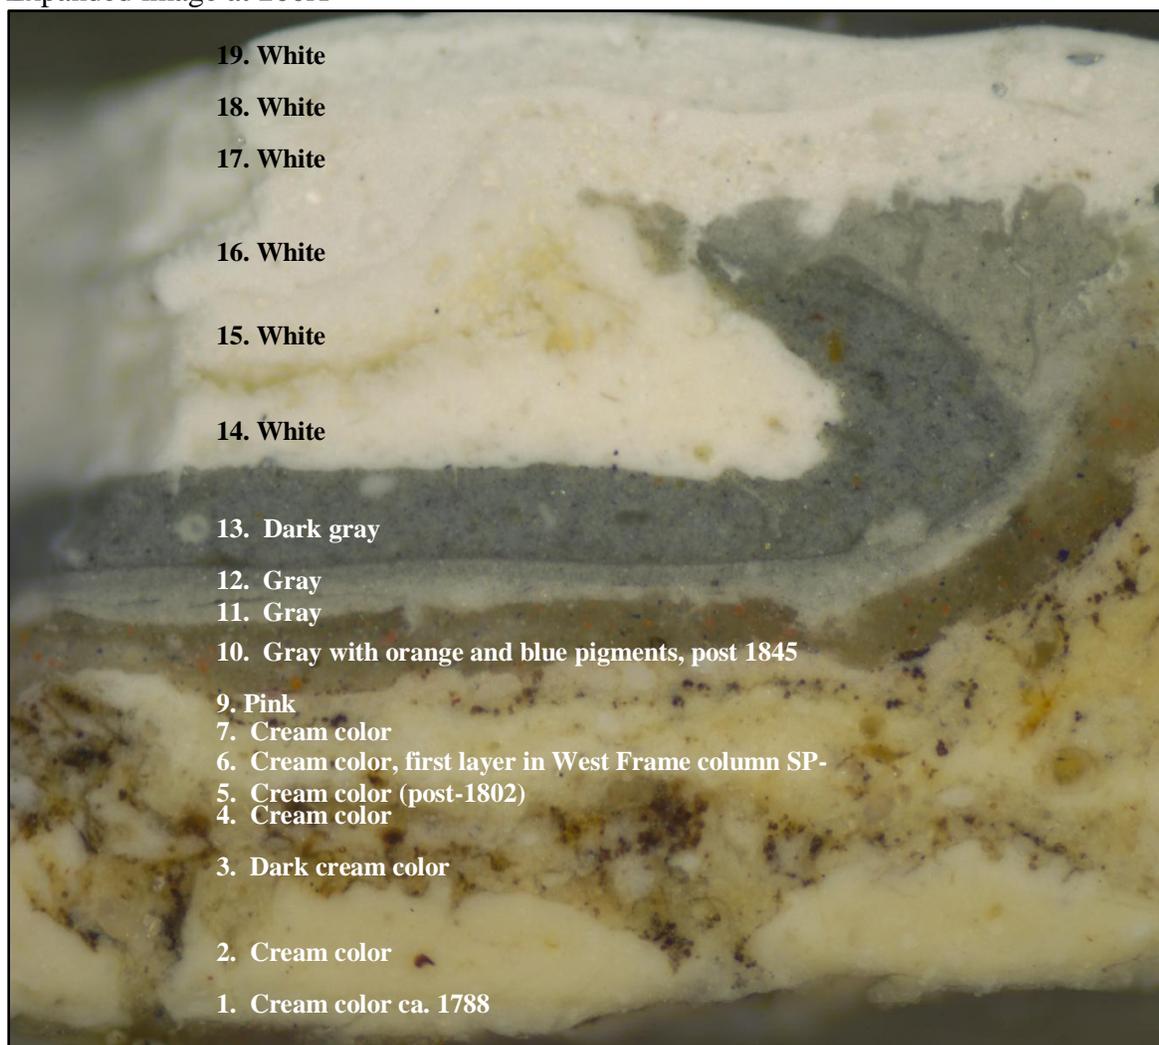
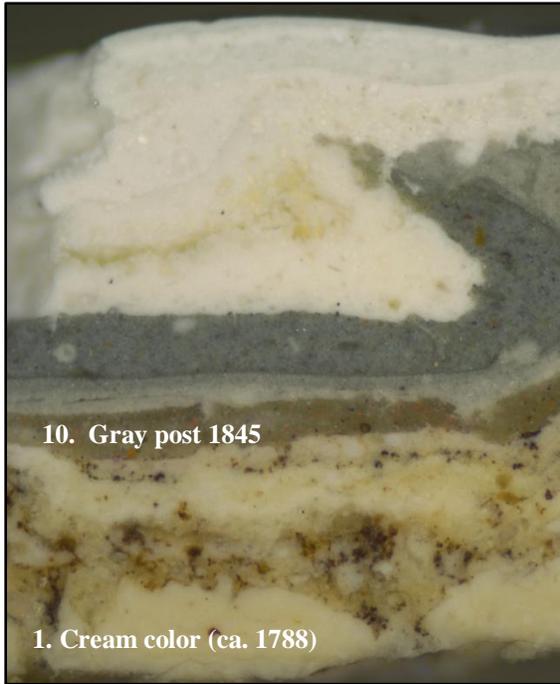
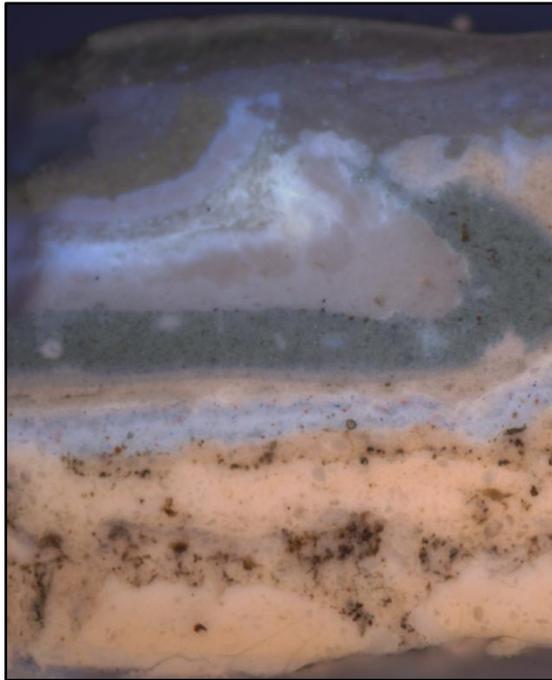
Sample SP-24. East Frame porch column. (DP)

East Frame and West Frame Porch Columns. The cross-section from an original South Porch column of the East Frame represents the most intact sequence of exterior trim paints found on the building. There are nineteen generations of paint, beginning with the first cream-colored paint that was found on the other original 1788 South Porch elements. The long sequence of cream-colored paints – from generation 1 through 7 – is consistent with the early paint evidence found on the window trim (SP-4 and NP-3), and sash (SP-5), and door frame (NP-2).

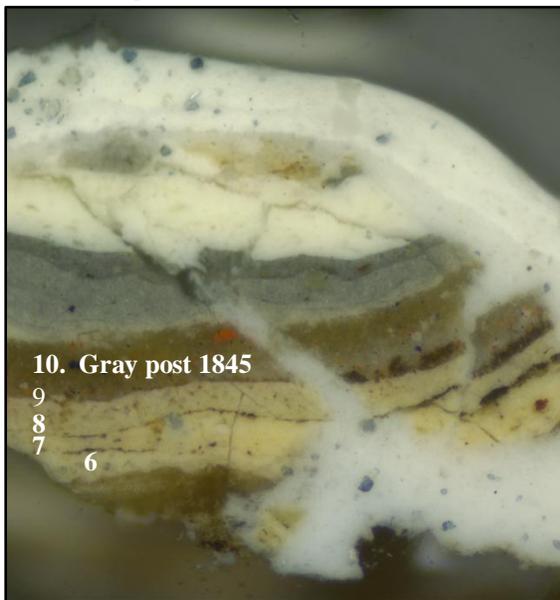
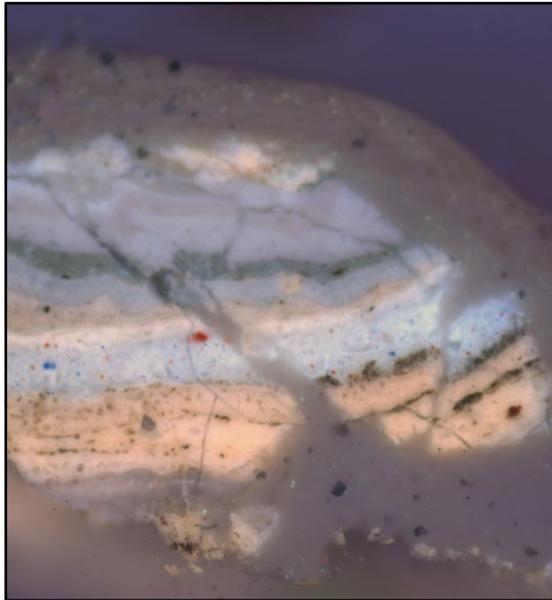
The cross-section from the West Frame porch column is more fragmentary, but it appears that the paint history begins at the generation 6 cream-colored paint found on the East Frame column (see below).

South Porch-29. Top of shaft of west column, west porch. Compare to SP-24.

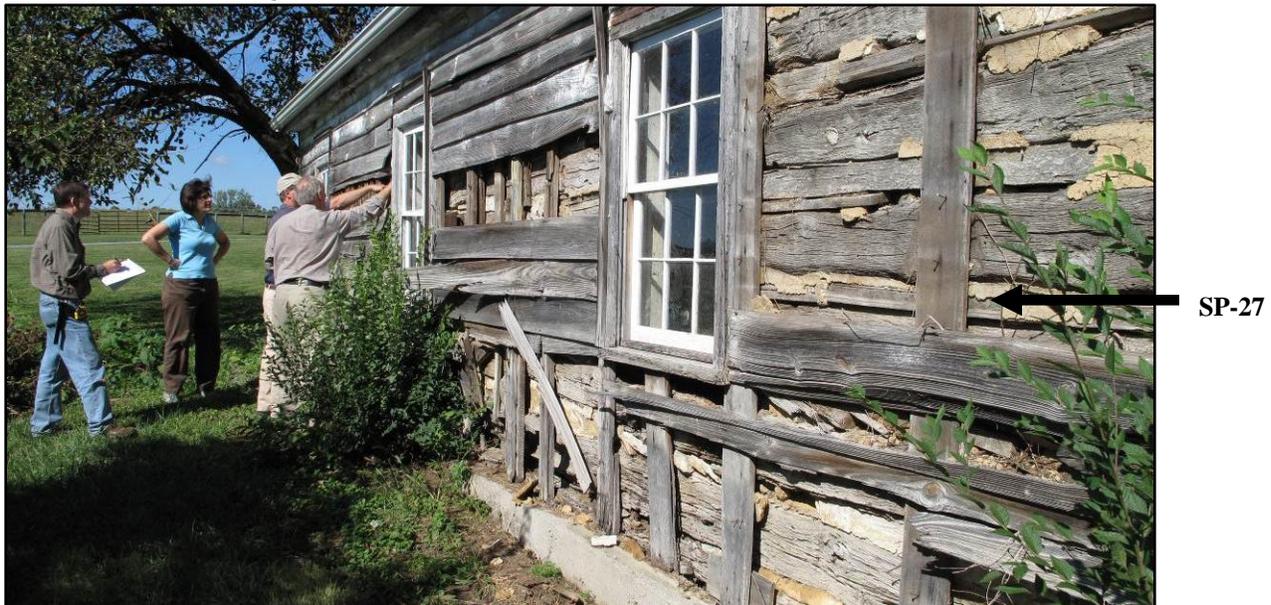
#### Location of SP-27

The most complete chronology was found in sample SP-27 from a section of handrail still embedded in the walls of the slave quarters. The evidence in this sample is quite revealing as the first paint layer above the wood is the medium yellow paint found as the first coating on the 1794 siding (see sample SP-2 for comparison). This is followed by the same two thick, coarsely ground verdigris-green paints found on the 1794 siding as generations 3 and 4, followed by the cream-colored paint identified as the post-1802 paint on the siding. Generations 6 and 7 are verdigris-based yellowish-greens not found elsewhere, followed two more finely ground green finish coatings before it was reused as chinking. This long chronology of coatings suggests that this particular section of handrail came from the east end of the South Porch and it may have been used as chinking during a later construction episode as the most recent green paint in SP-27 can be aligned with a ca. 1849 green paint on the South Porch benches and shelves.

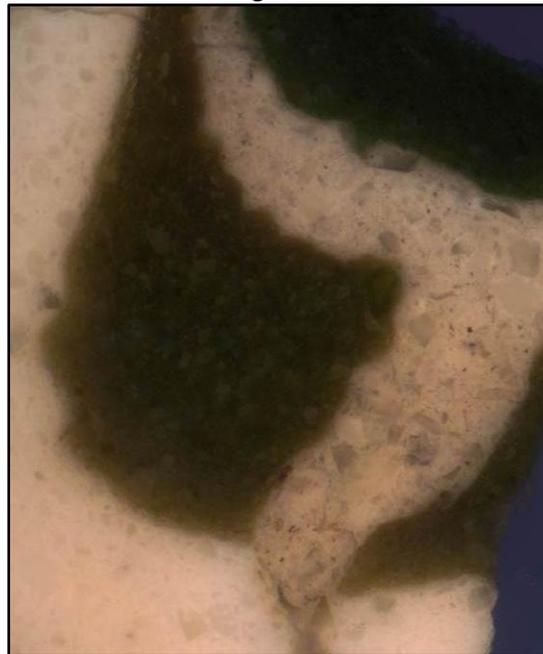
South Porch-25. Detached fragment of lower section of porch railing found by DP as a nailer in the Slave Quarters. Green paint on front edge.

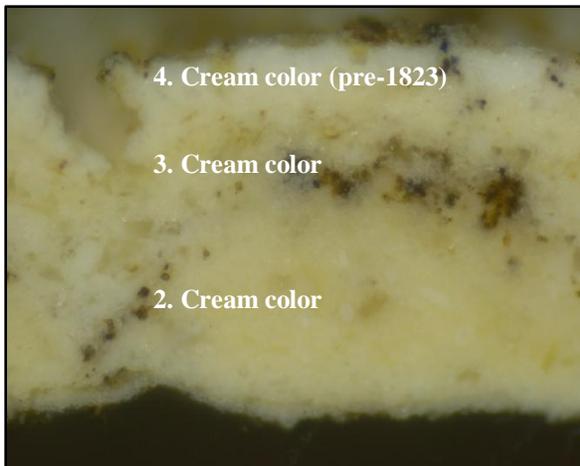
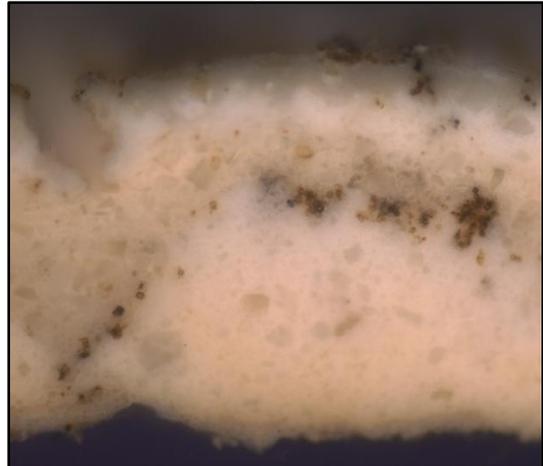
South Porch 26. Detached fragment of lower section of porch railing found by DP as a nailer in the Slave Quarters. White paint on top edge.

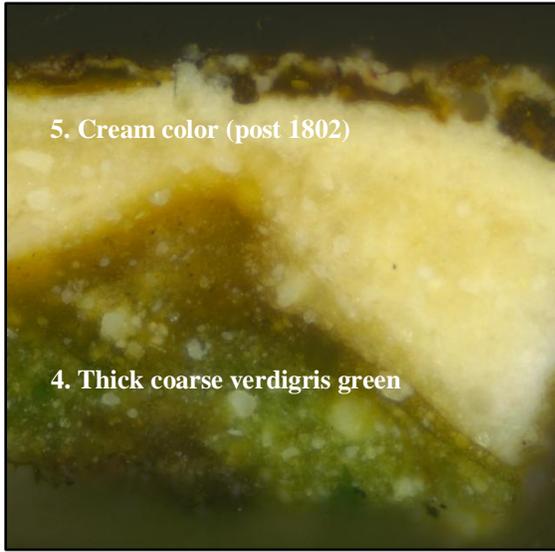
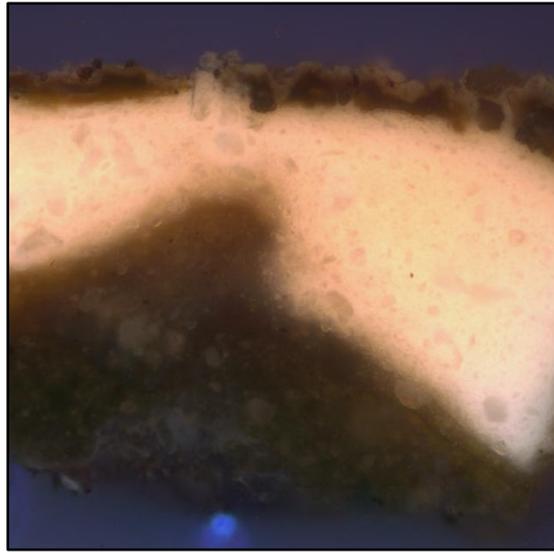
South Porch-28. Handrail fragment used as chinking on west side of slave quarters, white side.  
Visible Light 200X

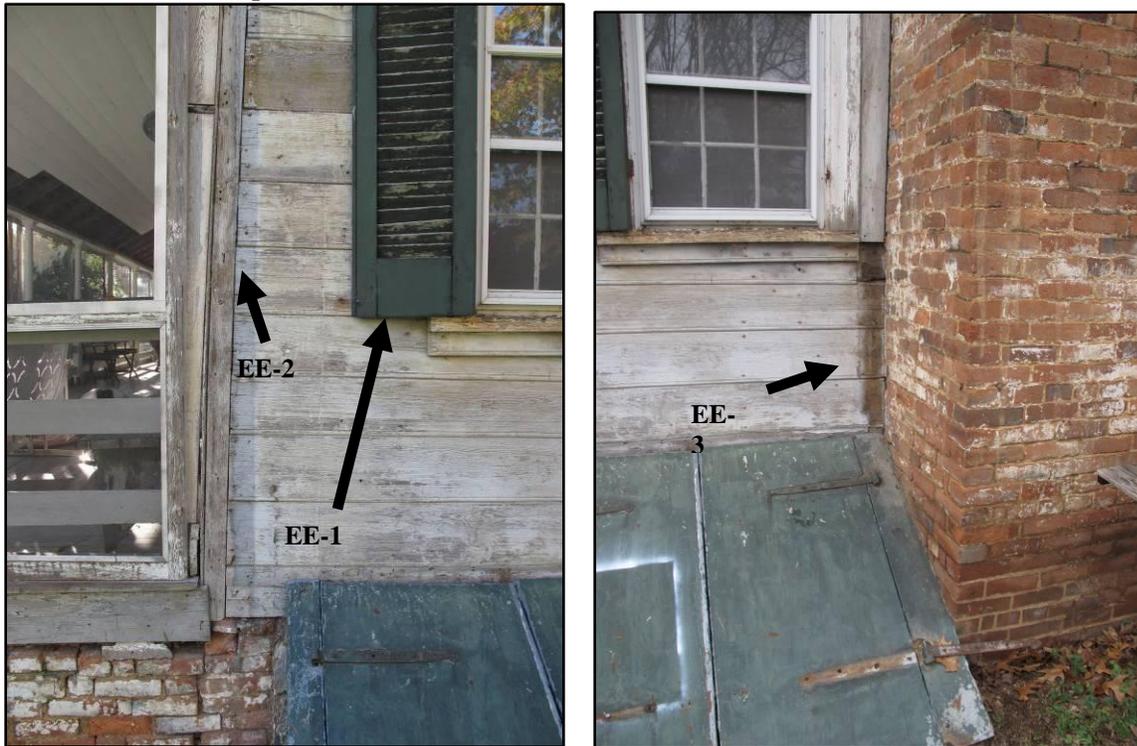
East Elevation Sample Locations

East Elevation-3. Paint on siding trapped behind cornerboard left of chimney.

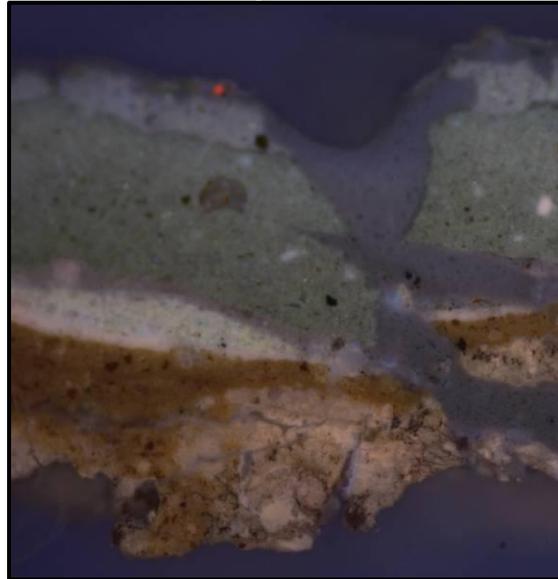
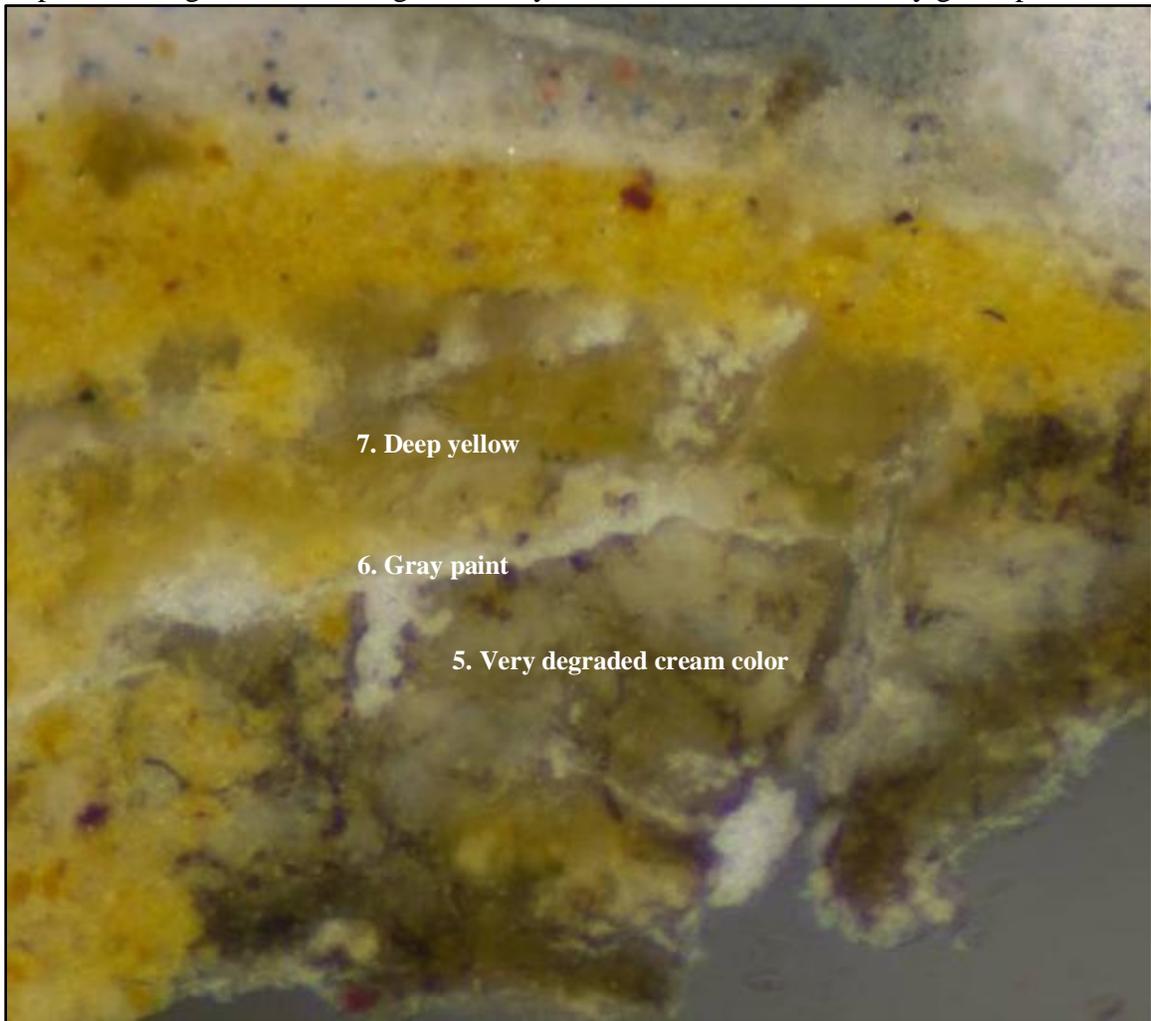
Sample EE-3 is also quite disrupted, and when its paint chronology is compared to the stratigraphy identified on protected areas of siding below the north and south elevation porches it becomes clear that the first layer remaining on this siding is generation 5. This initial dark cream-colored paint is quite degraded and discolored, but it is followed by generations 6 through 13, helping to confirm the context of the first cream-colored paint. This cream-colored paint was identified as the post-1803 paint layer on the West Frame.

East Elevation-3. Paint on siding trapped behind cornerboard left of chimney.  
Visible Light 100X

Expanded image of earliest fragmented layers show no evidence of early green paints

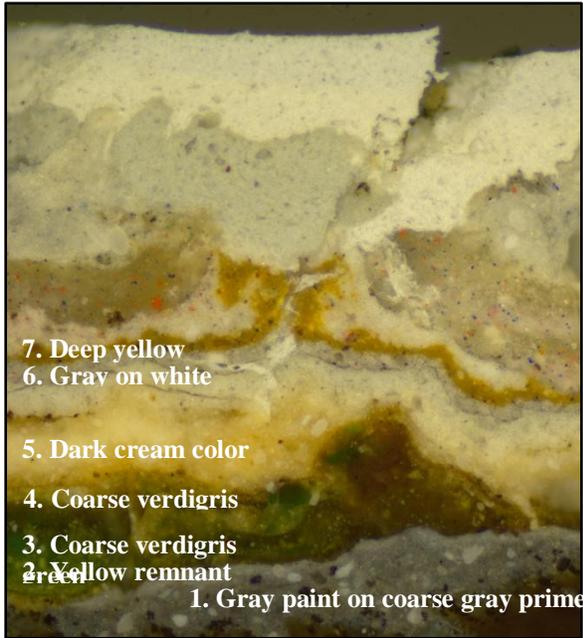
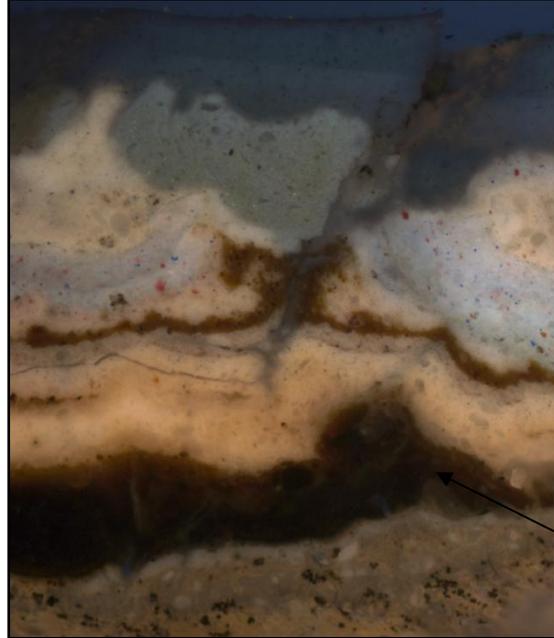
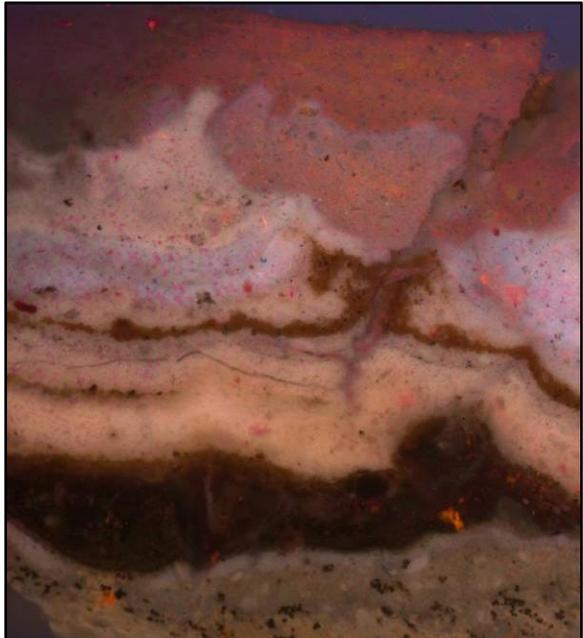
Positive reactions for oils in all layers

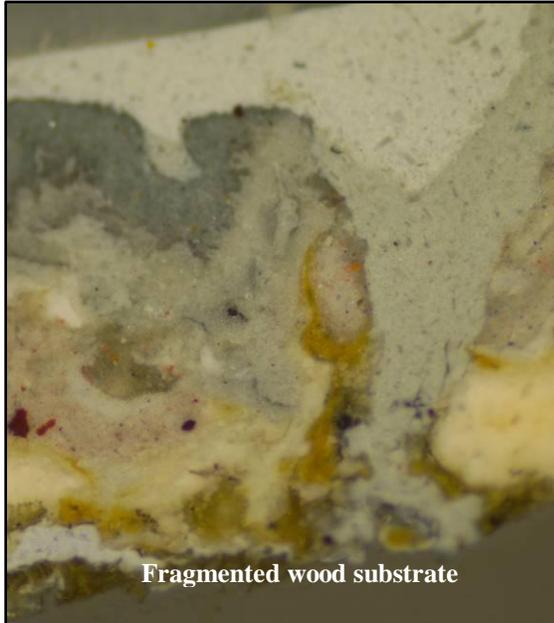
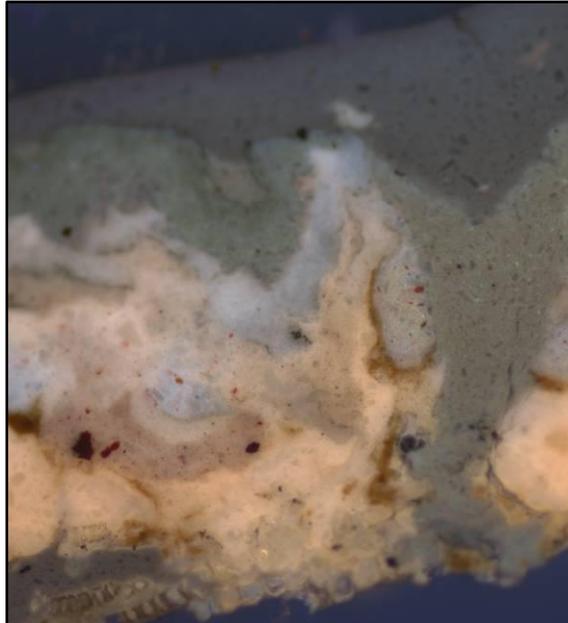
Sample NP-4. Siding with rosehead nails, on west frame, left of window, paint trapped behind shutter.

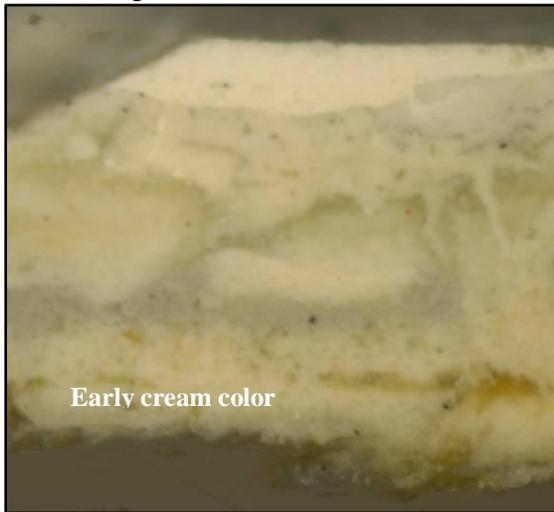
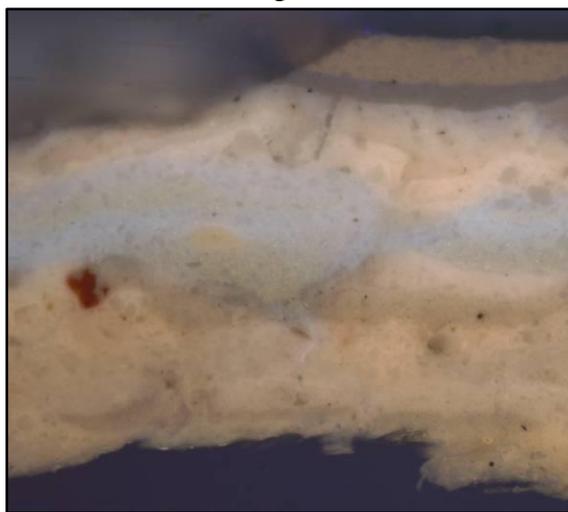
Three samples were taken from the siding and window on the West Frame, although on-site explorations showed these elements were considerably more weathered. There are early cream-colored paints on the window architrave (NP-5), but it is difficult to tell how the first cream-colored paint on this later window relates to the paint on the original north elevation window trim. The paints in samples NP-4 and NP-7 from the siding are similarly weathered, and the wood substrate is damaged, but the first paint layer in sample NP-7 appears to be the dark cream-color found as generation 5 on the West Frame siding on the south elevation.

Sample NP-5. Left architrave for west window of west frame.

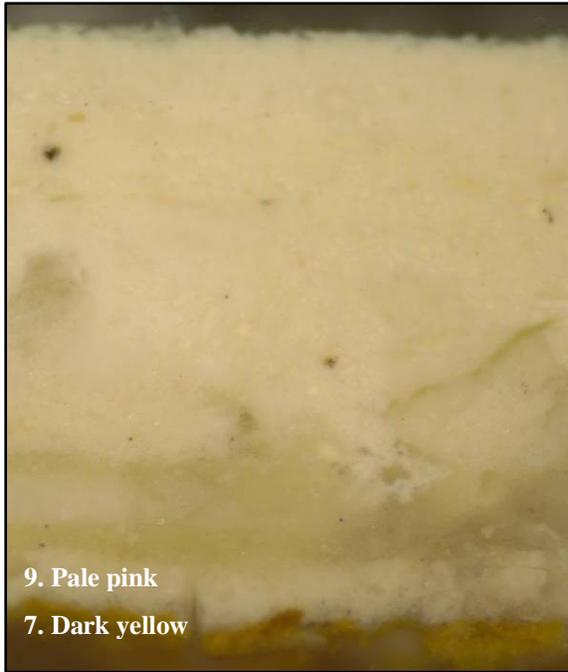
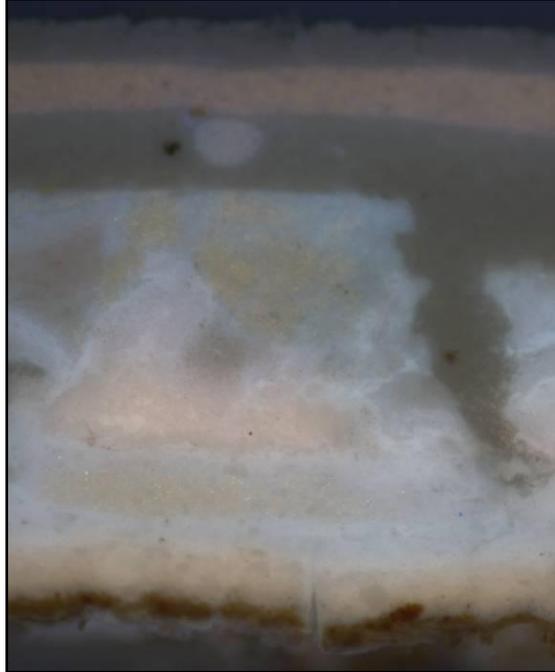
Sample NP-6. Soffit of pediment of later door trim.

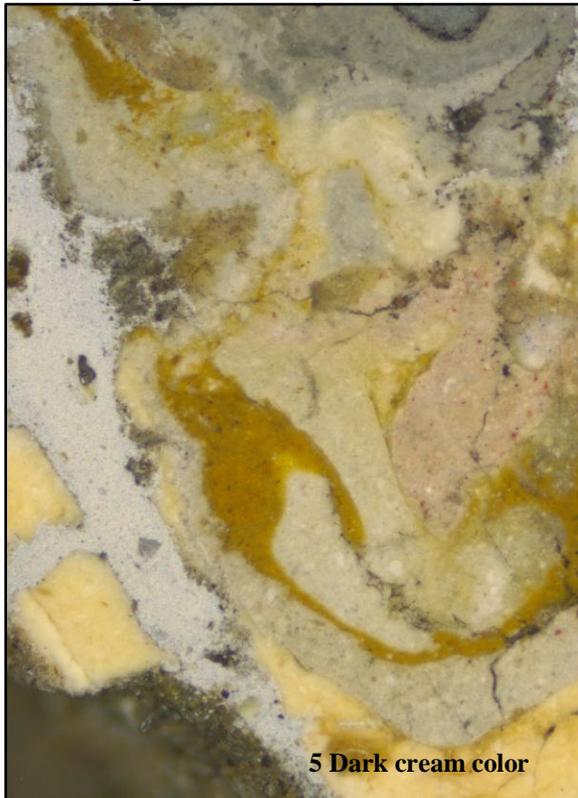
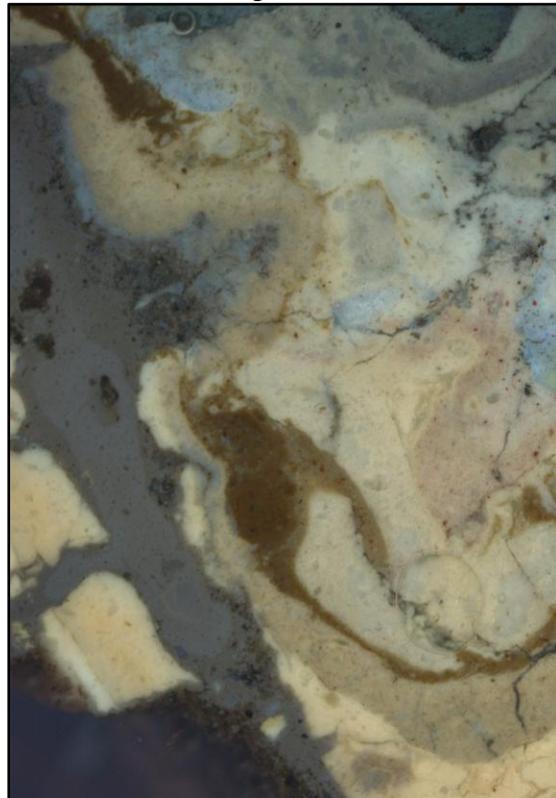
North Elevation-7. East face of west frame, siding, accumulation right of chimney.

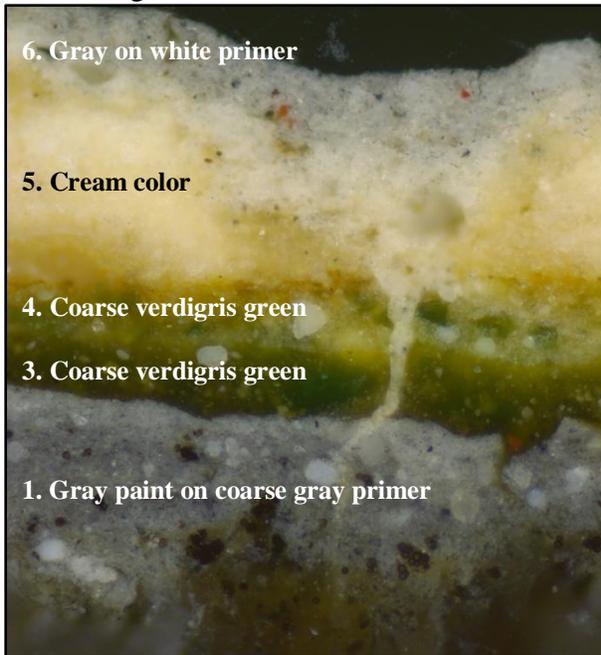
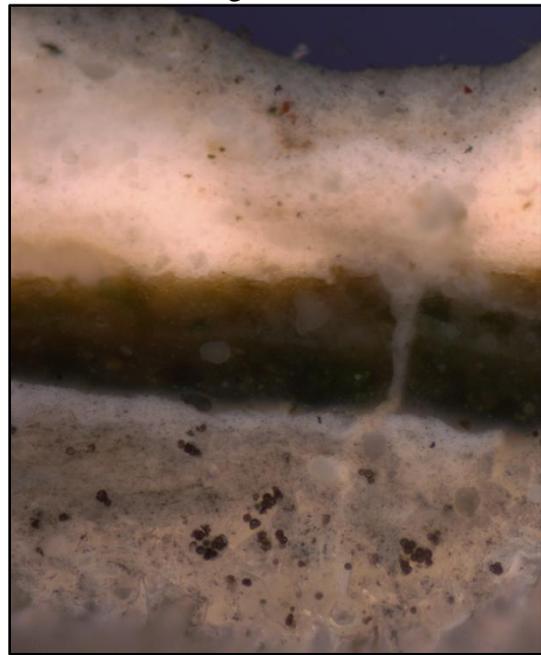
North Porch-8. Siding above door, to the right, surfaces trapped by later door frame.

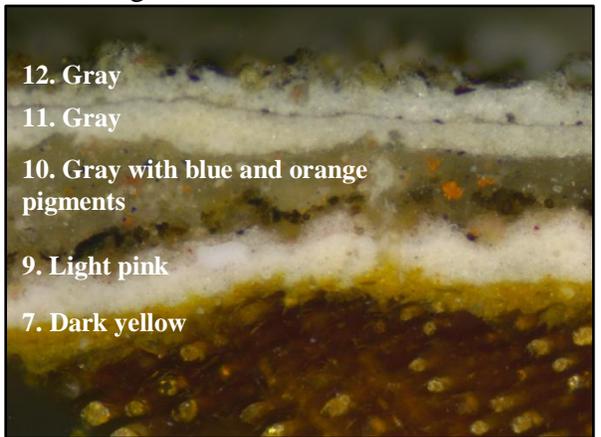
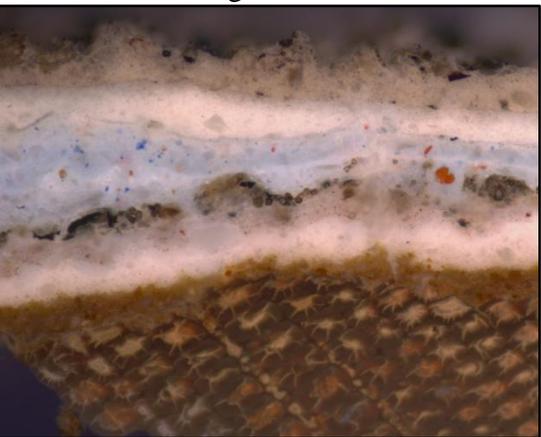
North Porch-9. Paint line, exposed above level of porch ceiling, showing there was an earlier porch.

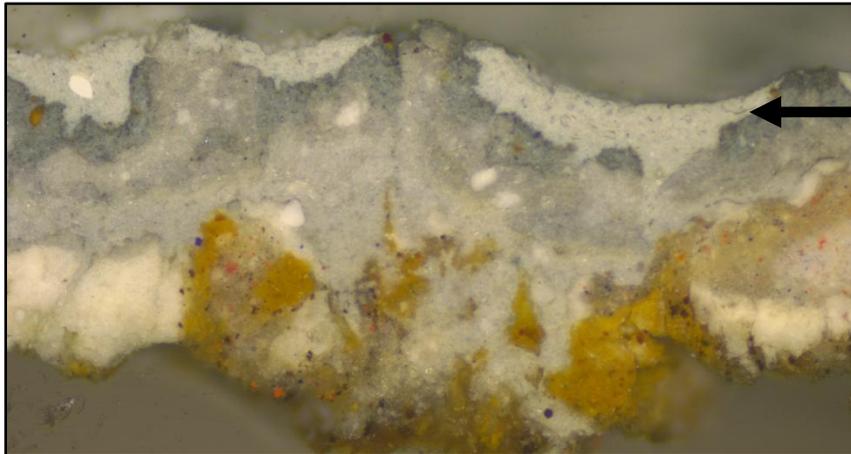
Gable-3. Trapped gable, west face of east frame, grayish weathered paints. Repolished sample for more information.

The dark gray in generation 13 is deeply weathered so it was exposed for a long time before repainting

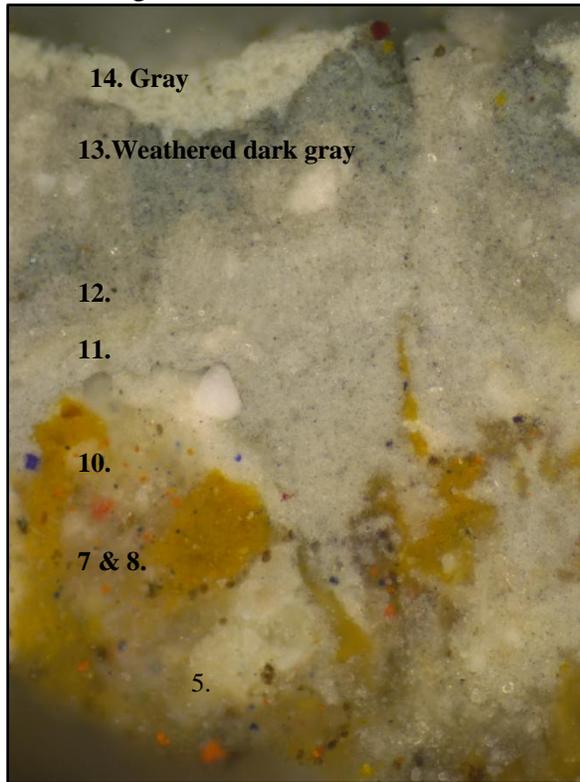
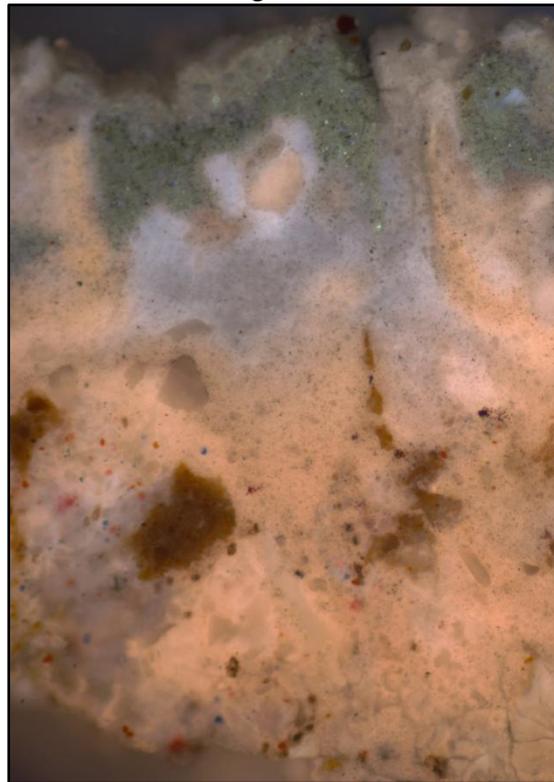
Gable-3. Trapped gable, west face of east frame, grayish weathered paints. Repolished cross-section for more information.
