**APPENDICES:**

**APPENDIX C: EXISTING CONDITIONS DRAWINGS**

**CLERMONT MAIN HOUSE AREA  
ARCHITECTURAL DEVELOPMENTAL HISTORY  
1756-1971**

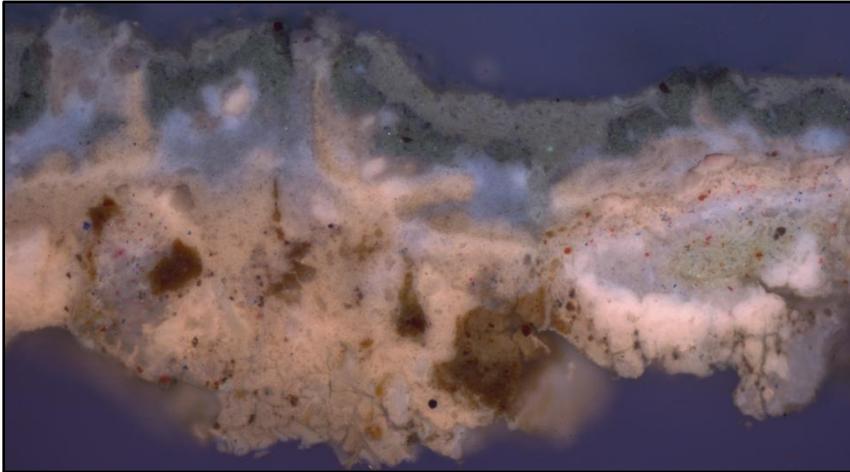
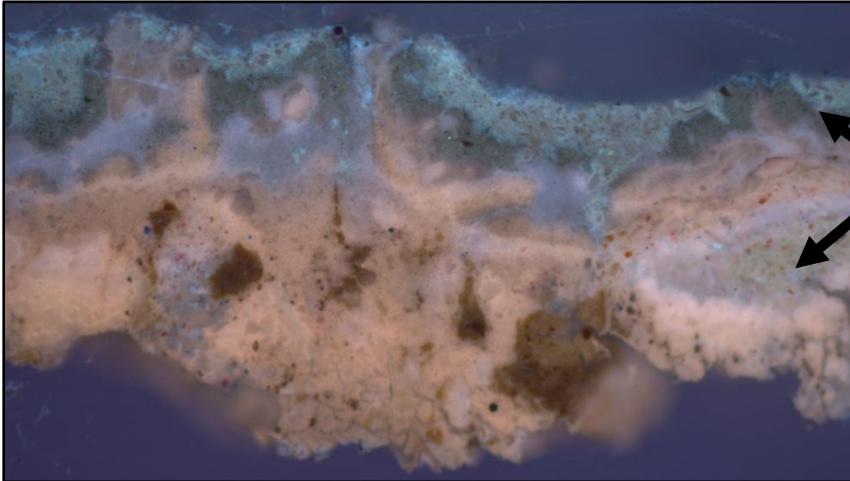
Gable-3. Trapped gable, west face of east frame, grayish weathered paints. Repolished sample for more information

**Positive reactions for zinc  
(bright light blue) in  
generations 10 and 14**

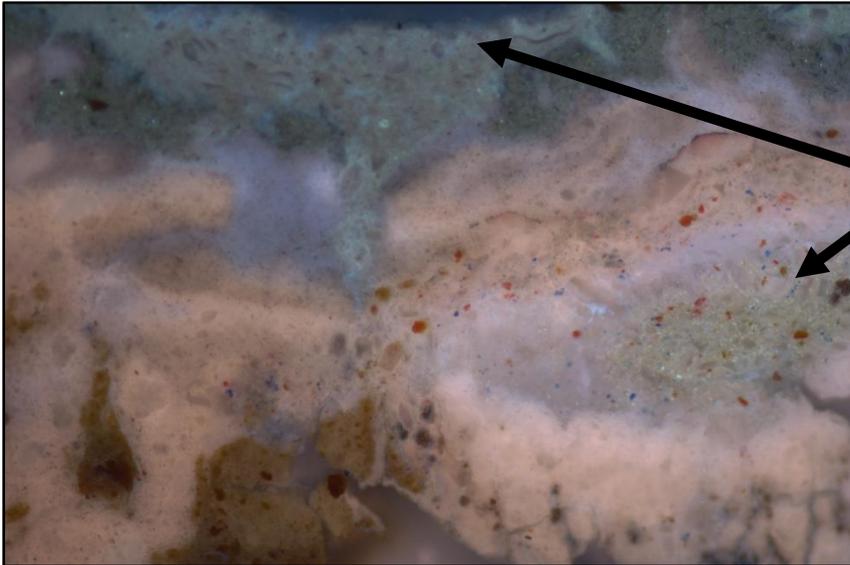
**Positive reactions for zinc  
(bright light blue) in  
generations 10 and 14**

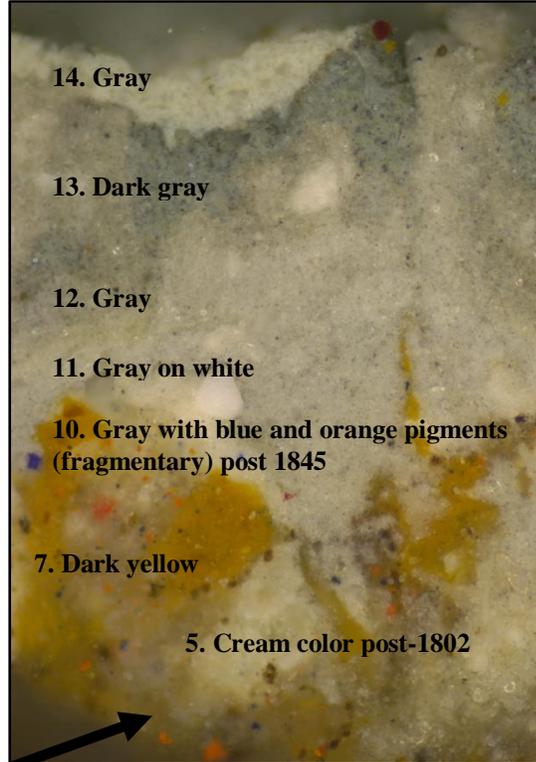
Gable-3  
Visible Light 200X

Fragmented, dirty wood substrate

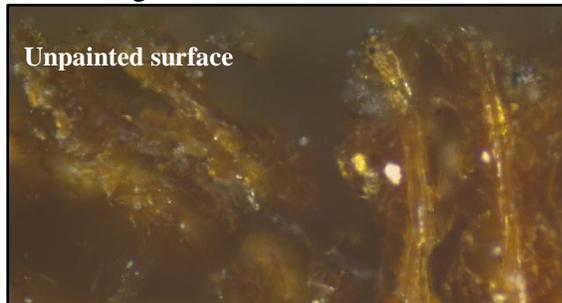
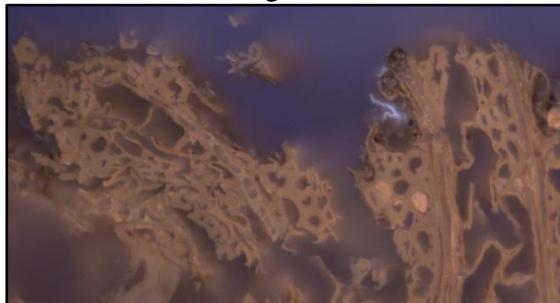
Gable-5. West face of east frame, trapped triangular area of siding next to chimney – cross-section shows this was never painted.

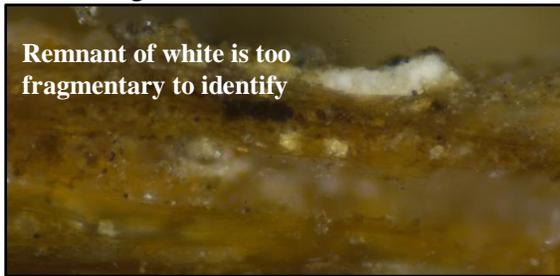
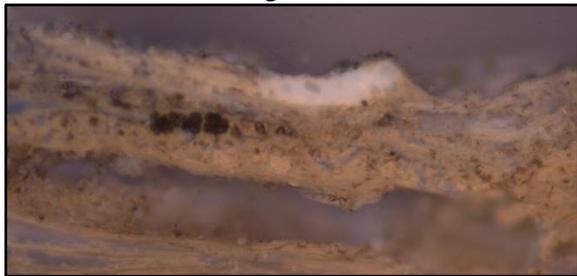
Gable-6. West facing siding, at right edge of hole made to insert later roof joist. Is there paint on the edge of this hole?

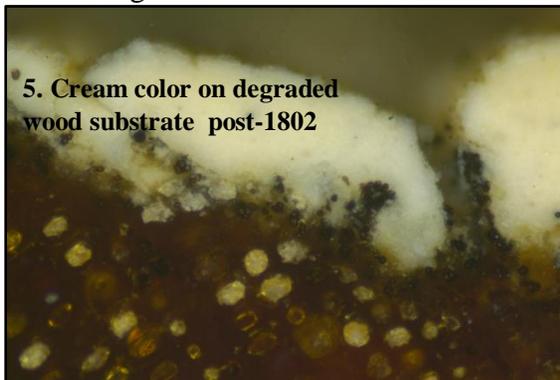
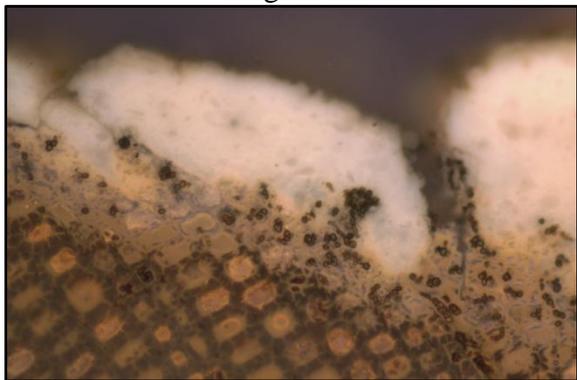
Gable-7. . Siding exposed above dropped ceiling in 107, painted surfaces on west-facing side of east gable. The first layer on the dirty wood substrate seems to line up with generation 5 on the siding, a post-1802 paint layer.

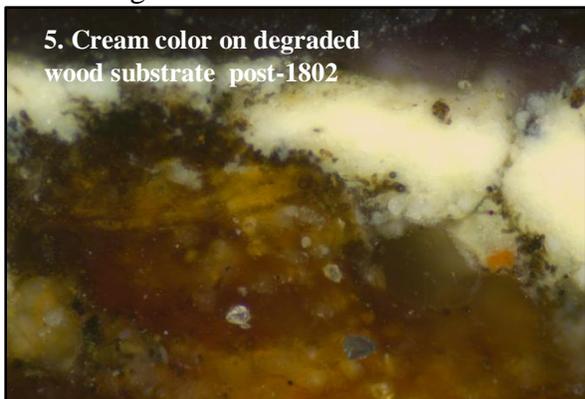
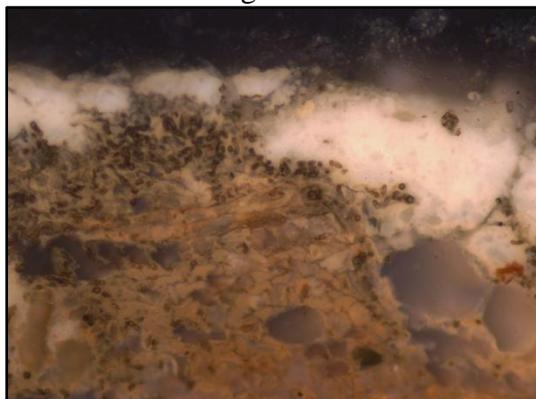
Gable-8. On trapped area of west-facing siding, on painted V ghost, behind existing ductwork, right of chimney.

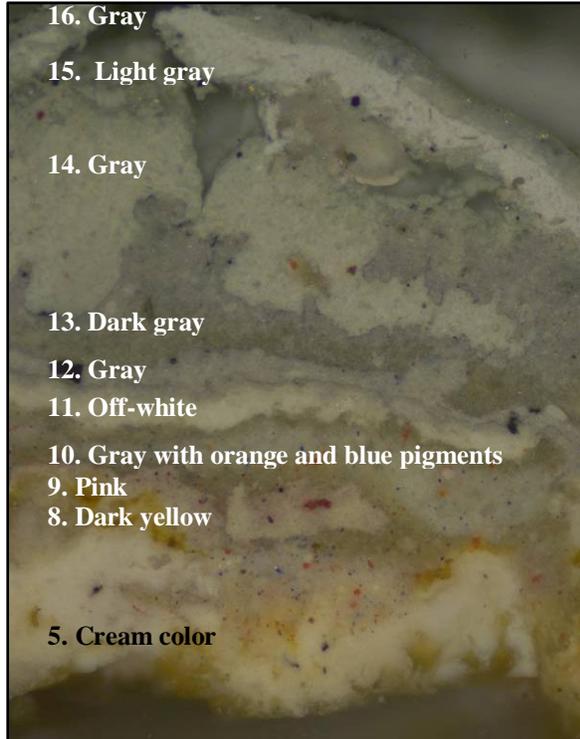
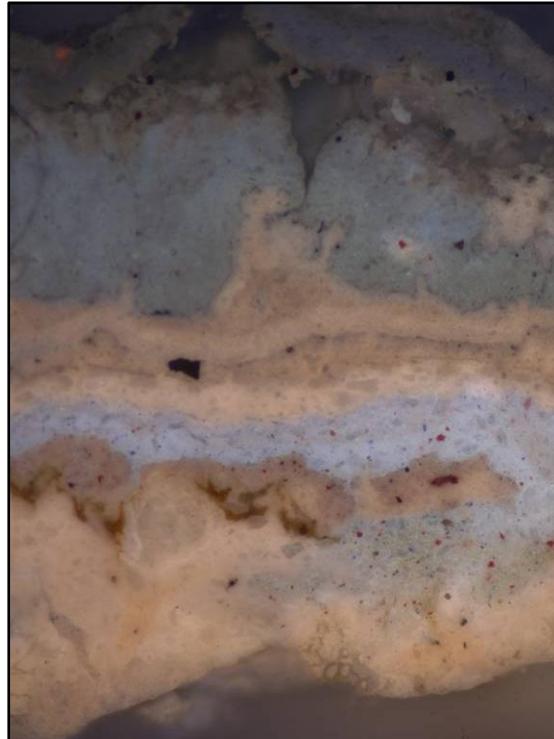
Detached Dormer Fragment. The paint history in the detached section of dormer siding also has a disrupted paint history, but it is possible to see that the paint history begins at the cream-colored paint applied in generation 5 (post-1802) and extends to the most recent gray paint found as generation 16.

Dormer-1. Board from side of dormer, lower edge at accumulated paint (section stored in room 202 after removal).

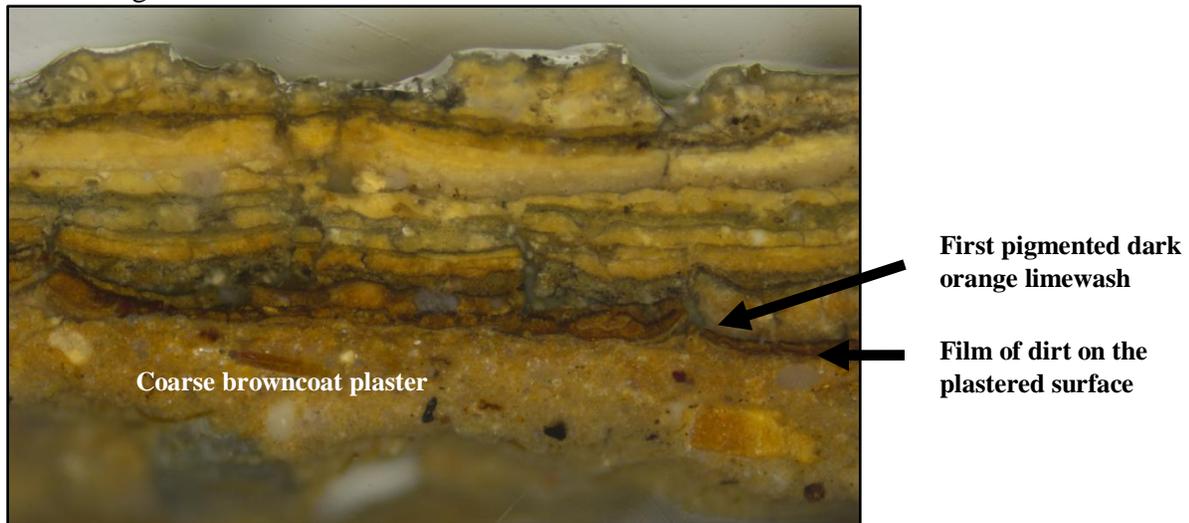
Sample K-1. North wall, early wall exposed above joist level, just above window (consolidated with Super Glue). There are at least fifteen generations of discolored, dirty, pigmented limewashes on top of a coarse brown coat of plaster that was applied to the joist before limewashing. The coatings now all appear brown by eye, but in cross-section the evidence suggests the first two generations were deep orange limewashes, followed a gray limewash and then by medium yellow limewashes. There are thick accumulations of soot between each layer, and deep cracks in the coatings, which suggests each layer was exposed for many years before repainting.

Sample K-1. North wall, early wall exposed above joist level, just above window (consolidated with Super Glue).

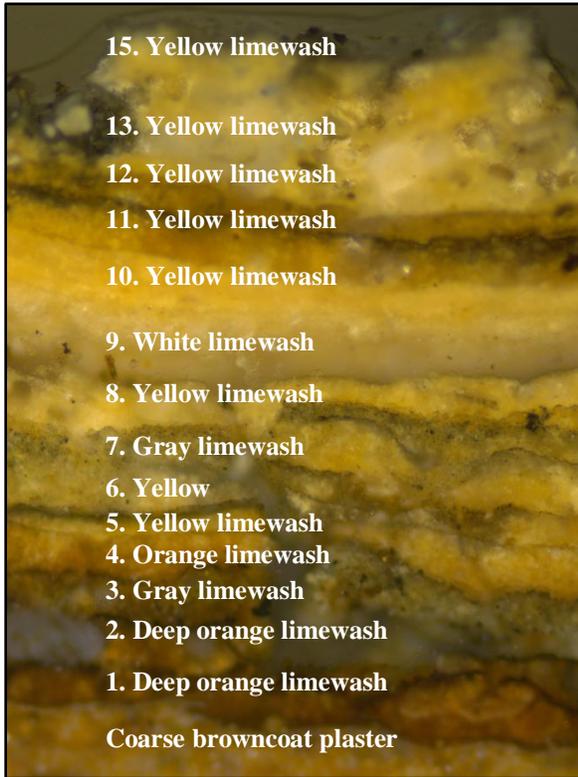
Sample K-1. North wall, early wall exposed above joist level, just above window (consolidated with Super Glue).

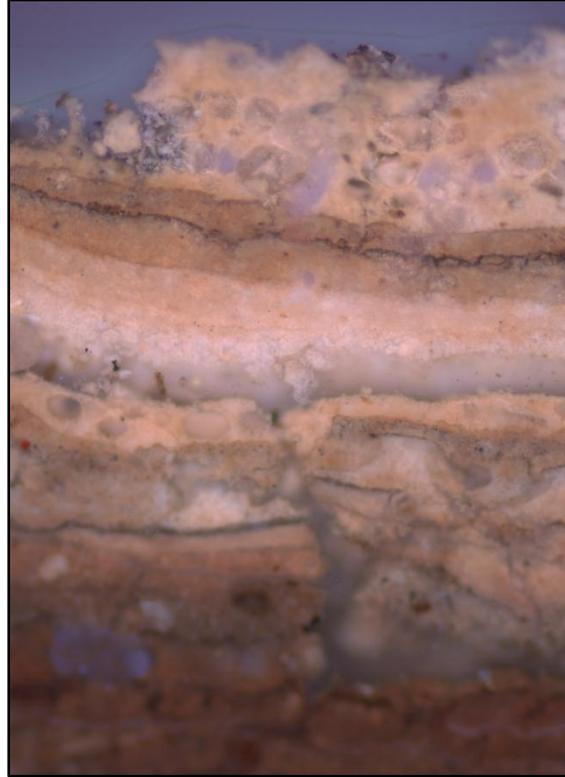
Sample K-2. West wall, NW corner, stuccoed stone wall above joist level.  
Visible Light 40X

Sample K-2. West wall, NW corner, stuccoed stone wall above joist level. There is a remarkable accumulation of coatings on the stucco, beginning with similar deep orange limewashes, followed by yellow washes, and then the most recent unpigmented (white limewashes). There are at least 27 generations of coatings with dirt and soot between each layer. The first two deep orange washes are the same as those found in sample K-1, suggesting the entire room could have initially been coated with the same deep orange wash.

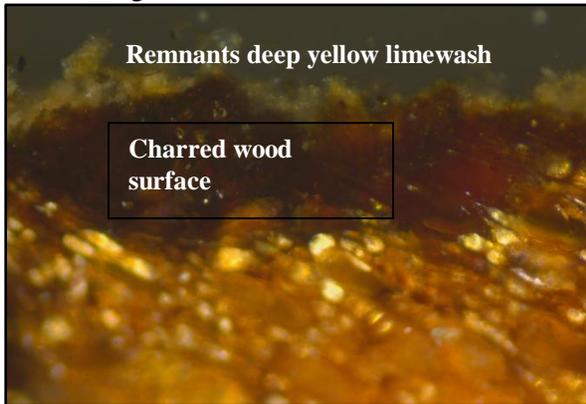
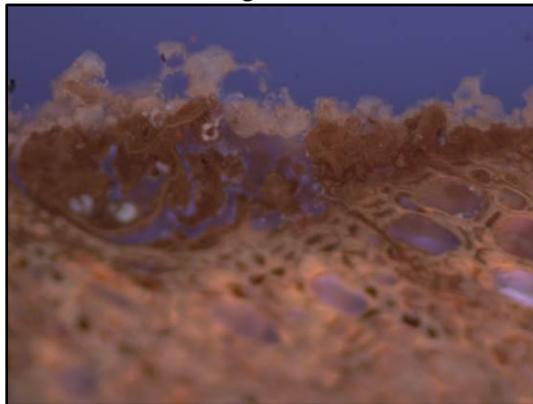
Sample K-5. West end, near fireplace, joist toenailed in across former stair opening. How do these washes compare to walls and to sample K-4?

Sample K-5. West end, near fireplace, joist toenailed in across former stair opening. The evidence in this sample is virtually identical to sample K-3 from the joist on the north side near the window. The wood surface is charred and disturbed, and the first coating is a deep yellow wash that can be approximately aligned with generation 13. This is followed by an unpigmented (white) limewash.

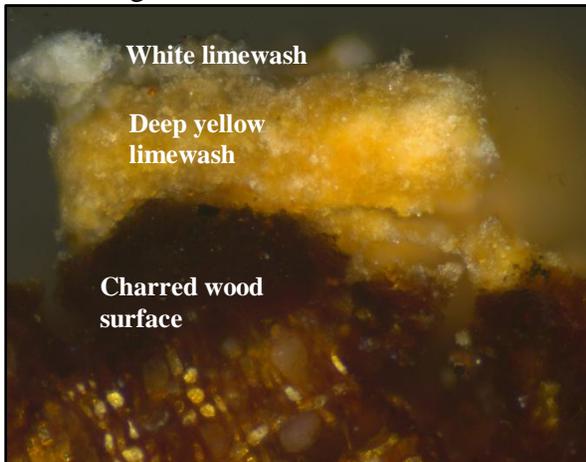
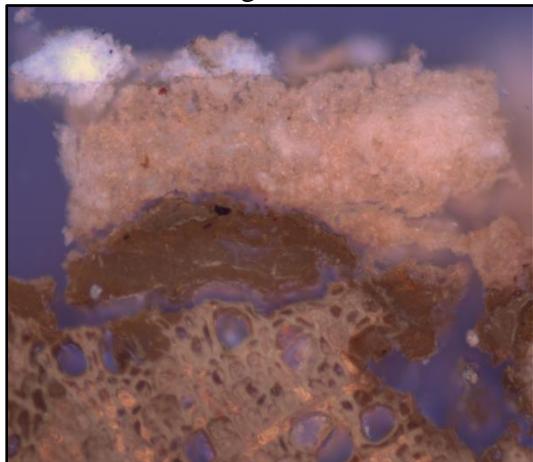
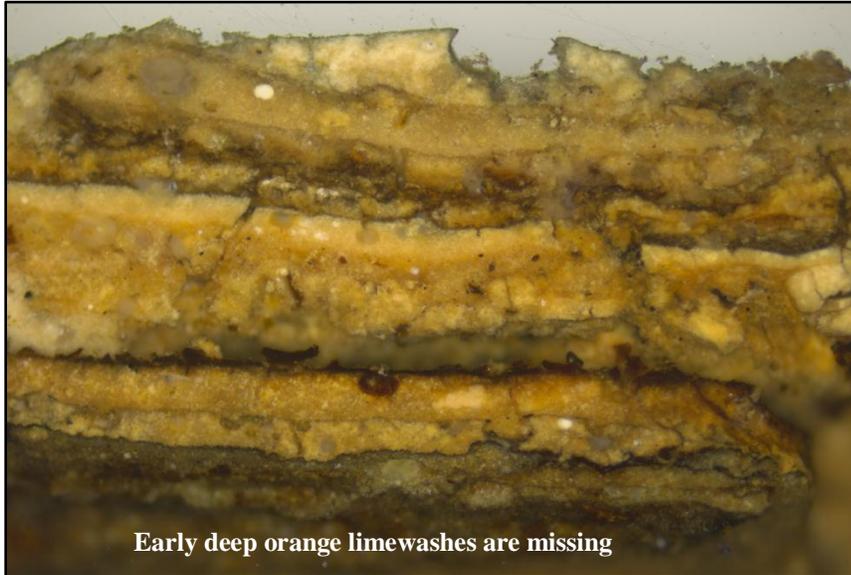
Sample K-6. East end, NE corner, washes on east side of joist near location of former fireplace, thick accumulation of washes. There is a thick accumulation of limewashes on the joist near the location of the early fireplace, but when it is compared to samples K-1 from north wall, and K-2 from the stuccoed stone wall about the level of the joists, this cross-section is missing the first two deep orange limewashes. The layer directly on the wood is the grayish limewash found as the third generation in sample K-1.

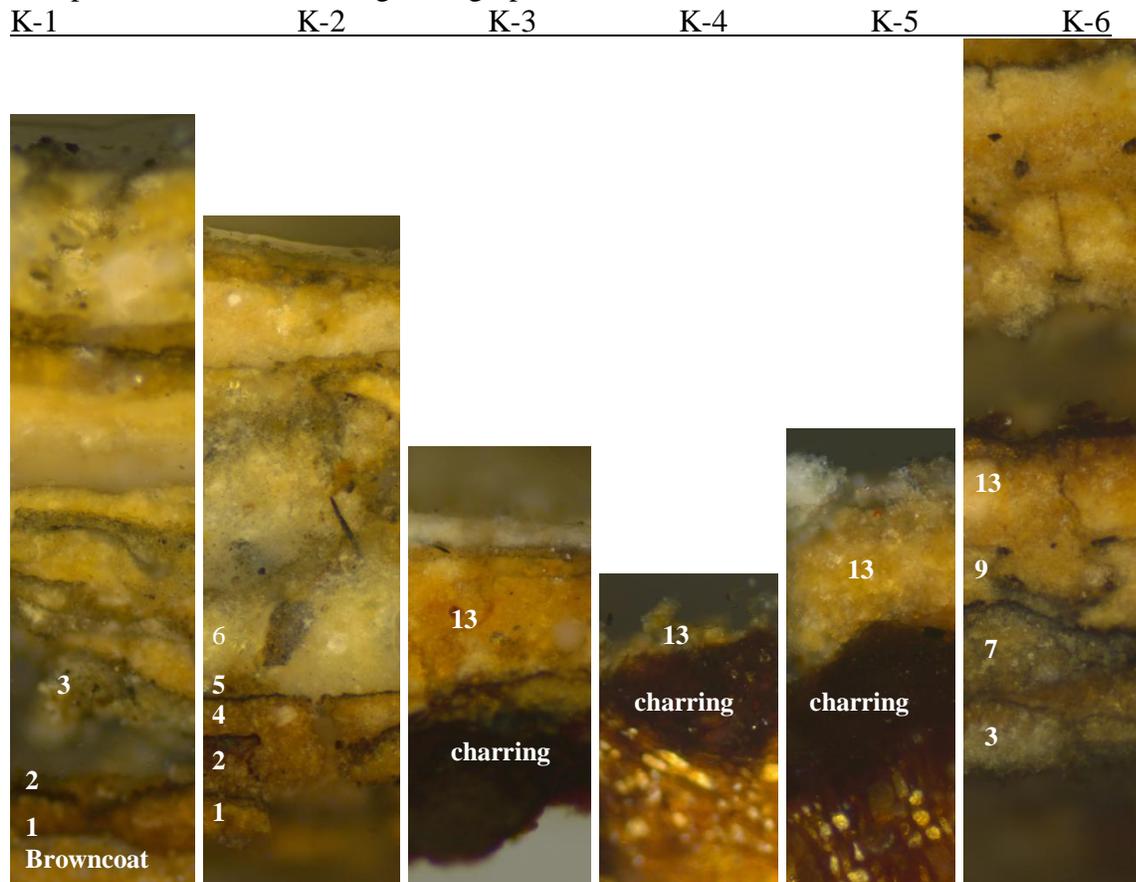
Comparative Kitchen Coating Stratigraphies

Analysis of six cross-sections from the interior of the 1777 kitchen shows that the interior was consistently recoated with pigmented deep orange, and then yellow, limewashes, with up to 27 generations of coatings remaining in the most intact sample K-2 from the stuccoed wall. The presence of soot and dirt between the coatings shows that the interior was allowed to become quite grimy before each recoating. It is difficult to make firm paint archaeology comparisons because of the fragile nature of these degraded limewashes, however, the comparative evidence suggests samples K-1 and K-2 represent original coating sequences, while the substrates in samples K-3, K-4 and K-5 appear blackened and charred, and the first coating on the charred wood seems to line up with generation 13. Sample K-6 is missing only the first two orange-pigmented washes, so this joist was installed fairly in the history of the interior.

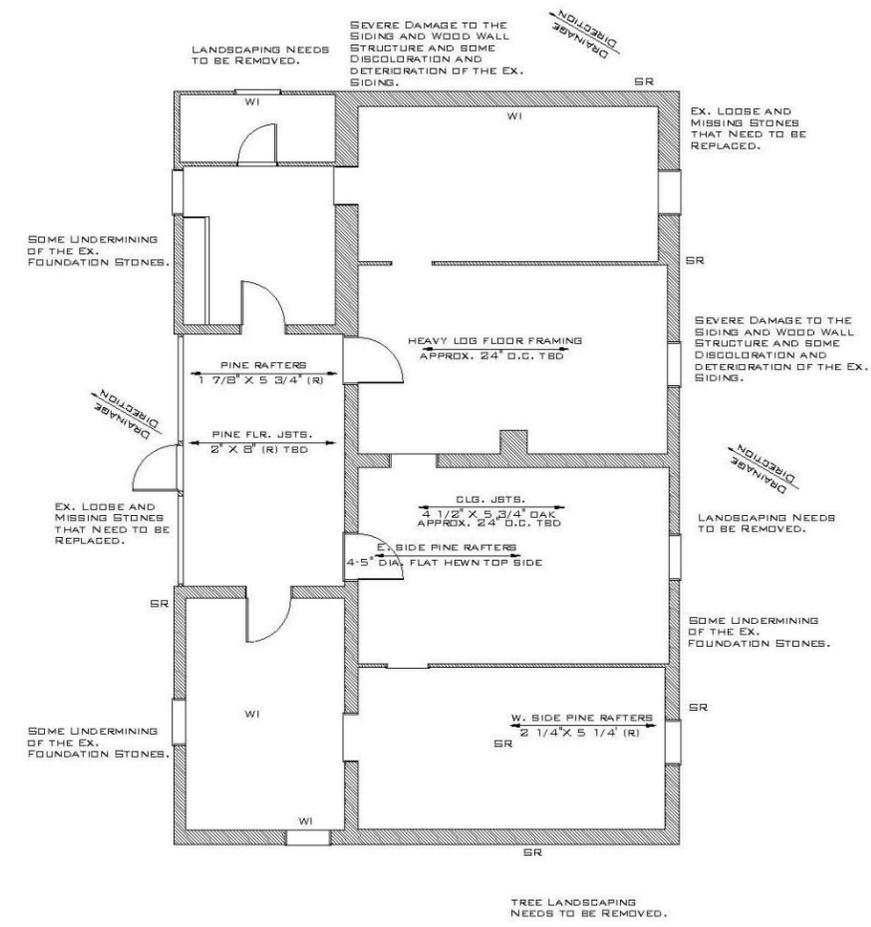
1 Existing Smokehouse Plan  
A1.4 SCALE: 1/4" = 1'

SR SIDING IS DAMAGED AND WATER APPEARS TO BE INFILTRATING INTO THE EX. TIMBER WALL SYSTEM.
